# Inspection Report

**1 Eucalypt Place, Heritage Park, QLD, 4118**

Report/Agreement #      140125112928608

Inspection Date:      14 Jan 2025

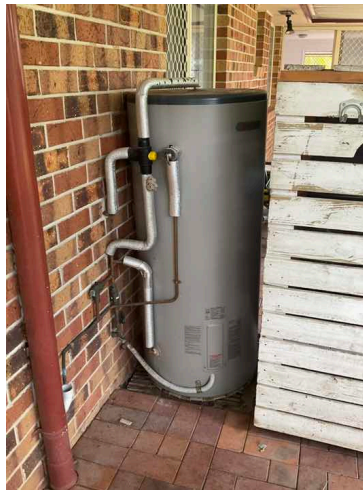
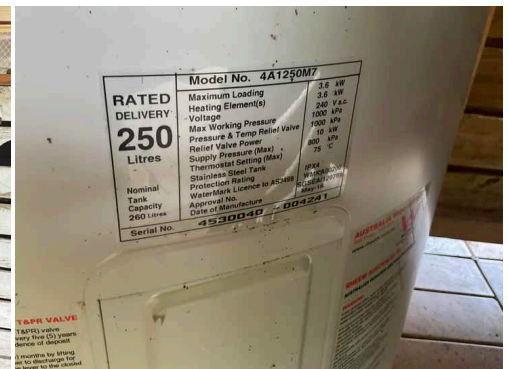
### Hot Water Unit Findings

The hot water system appears to be in a serviceable condition. No specific tests other than running the hot water from a tap was carried out. No determination has been made as to the suitability or adequacy of the hot water system in relation to capacity or otherwise.

The hot water unit is located outside.

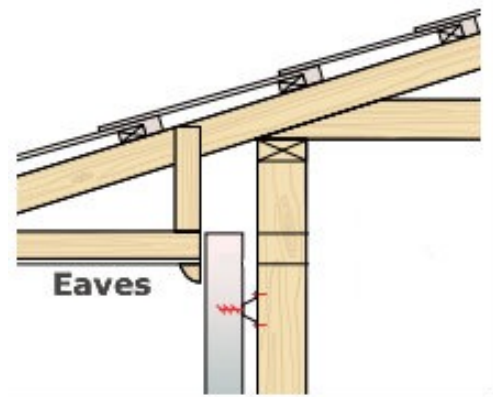
### Eave Condition

The soffit lining (eaves) are in a serviceable condition with no notable defects.

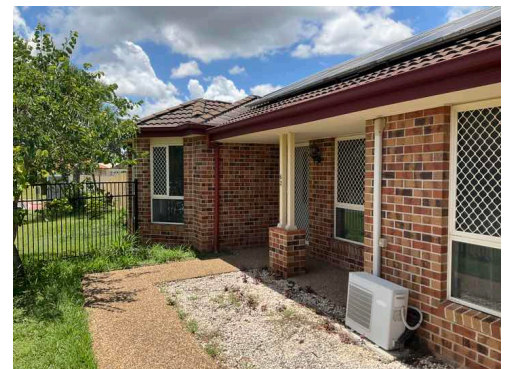
## Entry Porch Area

The entry porch serviceable or in reasonable or condition for the age of this dwelling.

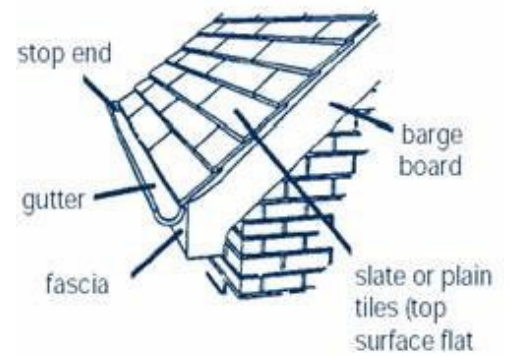
### Condition

On visual inspection, the general condition of the fascia/barge boards is serviceable.

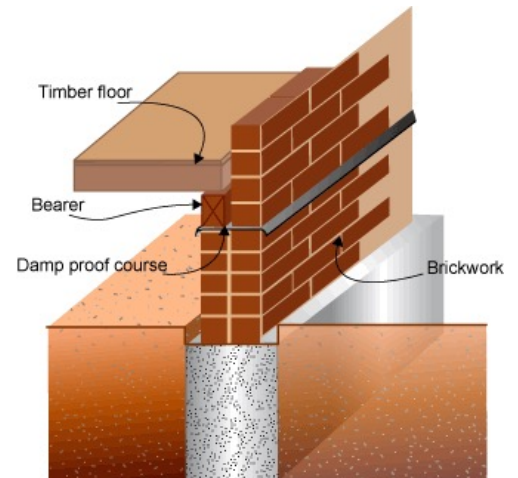
### Damp Proof Course

A damp proof course (DPC) was noted.

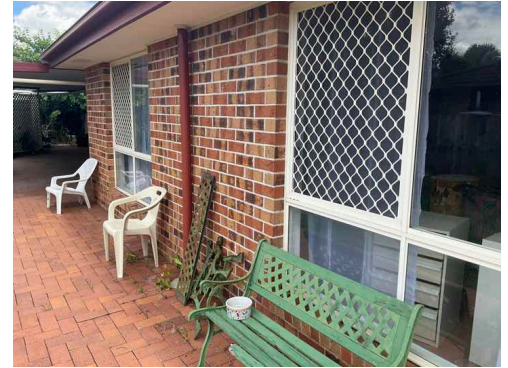
**Exterior Wall Material**

Brick.

On visual inspection, the general condition of the exterior walls is serviceable for the age.

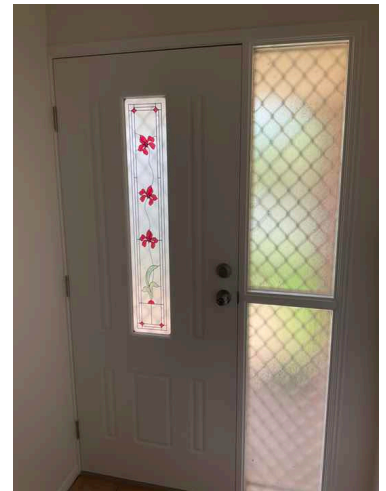
#### Front Entry Doors

The doors are in serviceable condition with no notable defects observed.

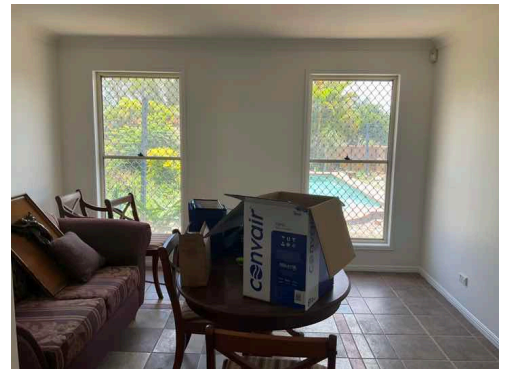
From the visible and accessible areas, this room appears to be in a serviceable condition for the age of the property with no notable structural defects sighted.

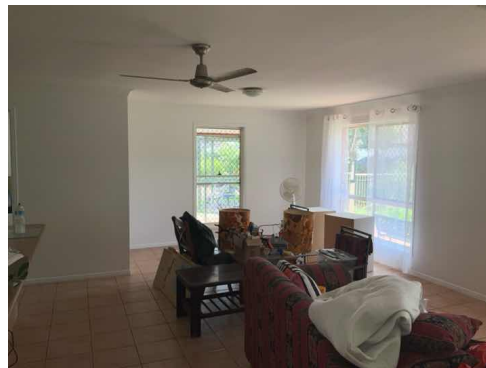
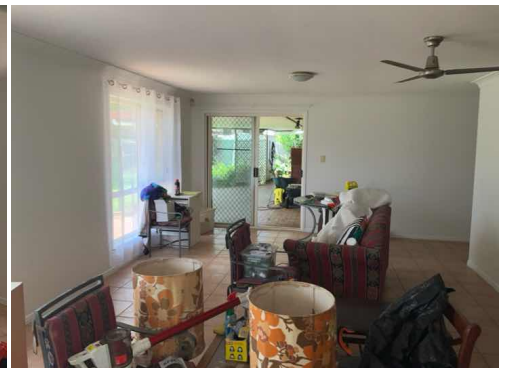
## Combined Living & Dining

From the visible and accessible areas, this room appears to be in a serviceable condition for the age of the property with no notable structural defects sighted.

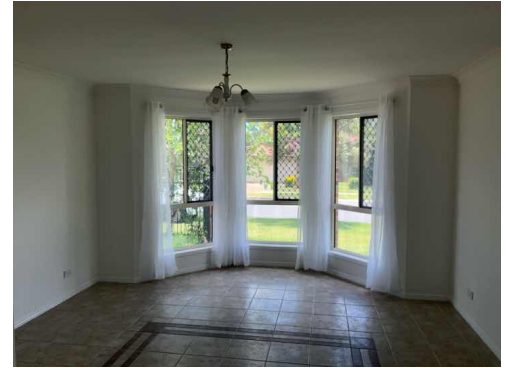
## Family Room

From the visible and accessible areas, this room appears to be in a serviceable condition for the age of the property with no notable structural defects sighted.

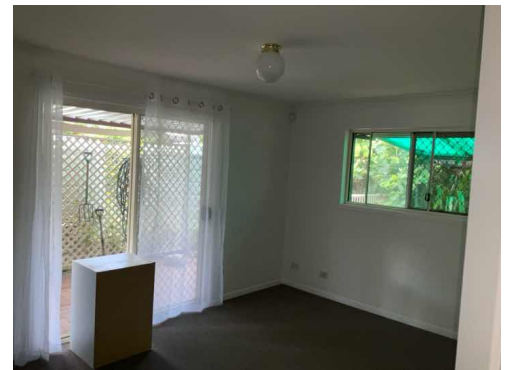
From the visible and accessible areas, this bedroom appears to be in a serviceable condition for the age of the property with no notable structural defects sighted.

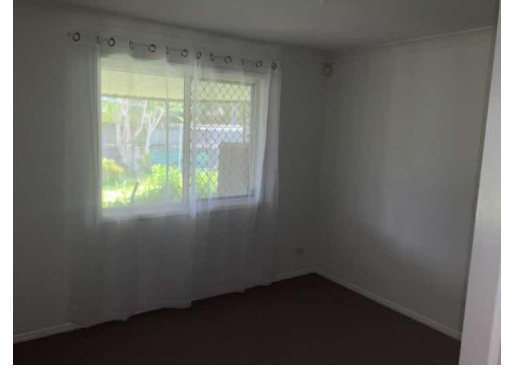
## **Bedroom 2**

From the visible and accessible areas, this bedroom appears to be in a serviceable condition for the age of the property with no notable structural defects sighted.

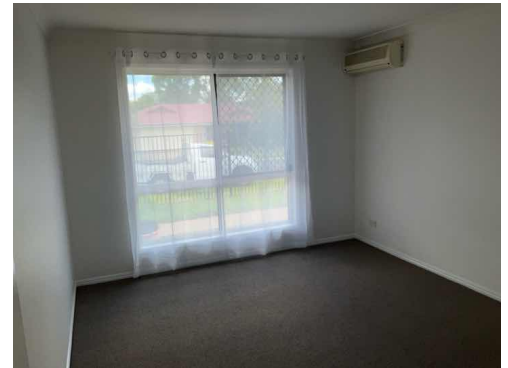
## **Bedroom 3**

From the visible and accessible areas, this bedroom appears to be in a serviceable condition for the age of the property with no notable structural defects sighted.

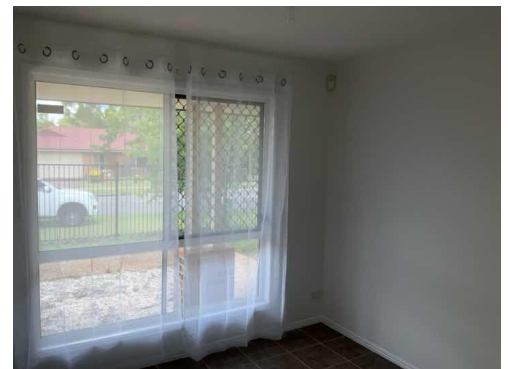
## **Bedroom 4**

From the visible and accessible areas, this bedroom appears to be in a serviceable condition for the age of the property with no notable structural defects sighted.

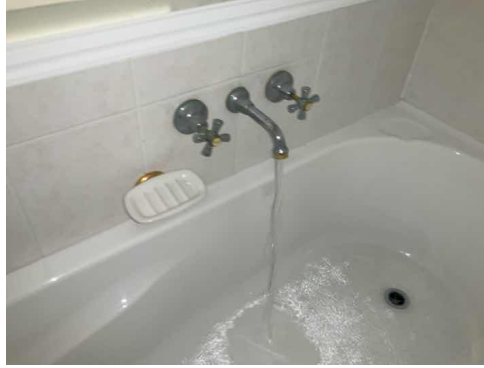
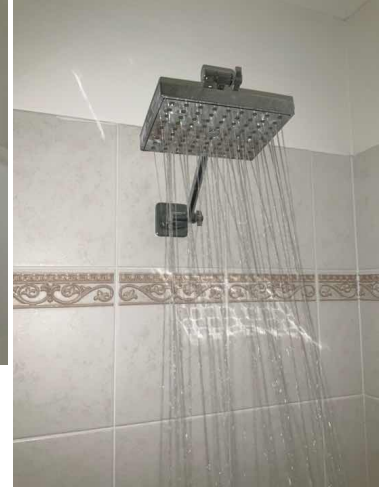
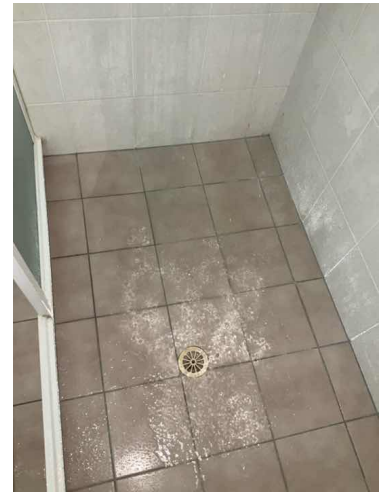
Of the visible areas, the general condition of this bathroom is serviceable or in reasonable condition for age of dwelling.

Accurate assessment of moisture can not be achieved due to the property being vacant at the time of the inspection

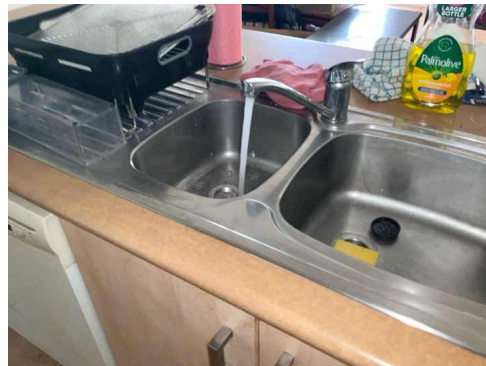
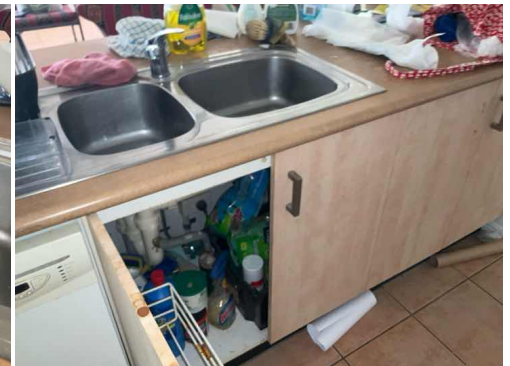
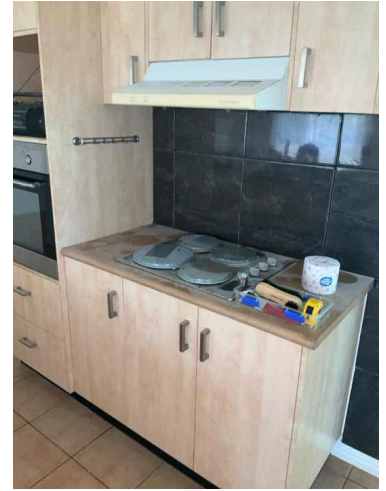
### Kitchen and Pantry

Of the visible areas, the general condition of the kitchen is serviceable or in reasonable condition for age of dwelling.

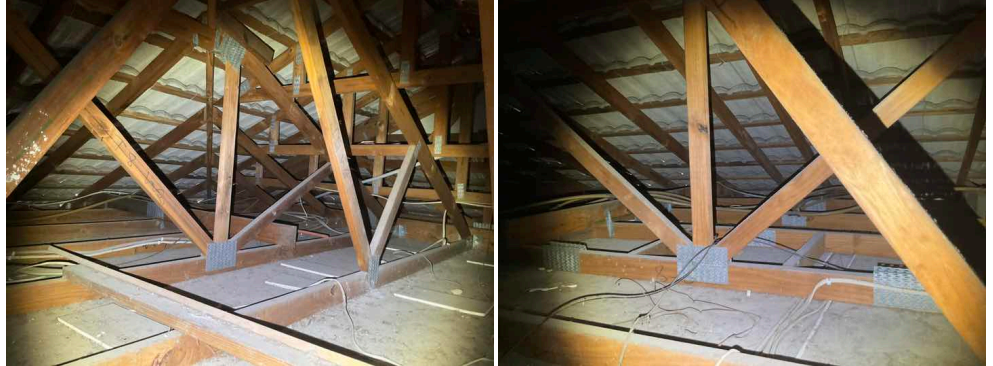
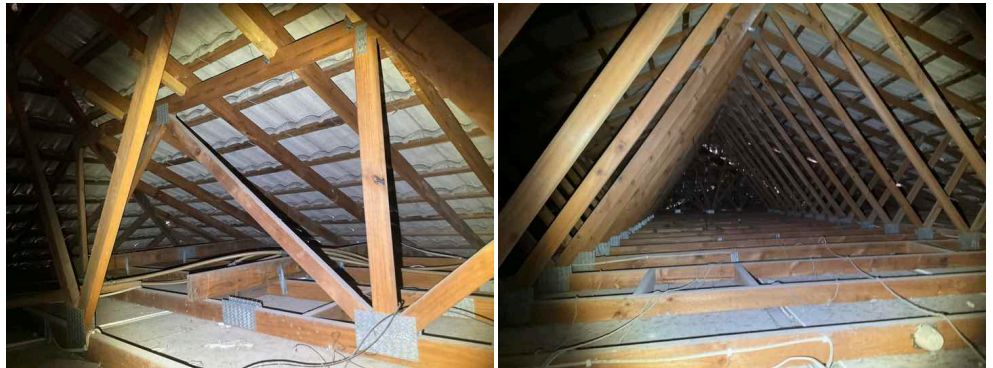
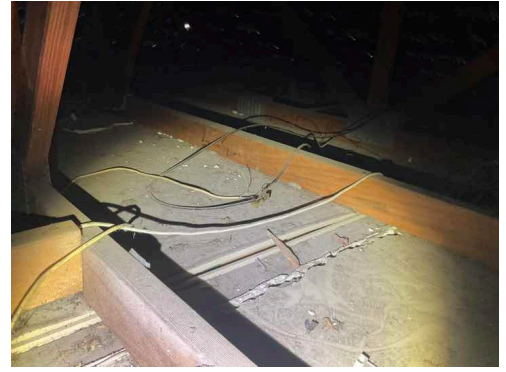
Visible sections of the roof void is in a serviceable condition for age of this dwelling.

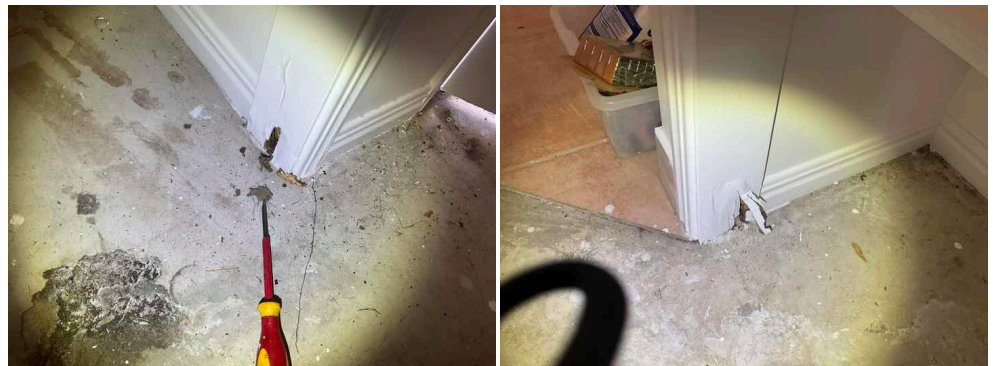
Where evidence of termite activity was found in the grounds then the risk to buildings is extremely high. A treatment to eradicate the termites and to protect the building(s) should be carried out in the first instance.
