Pre Purchase Building and Pest Report

Inspection Address

32 The Comenarra Parkway, Thornleigh, NSW, 2120

Report/Agreement #	02122212501693
Inspection Date:	02 Dec 2022
Inspection Time:	12:50 pm

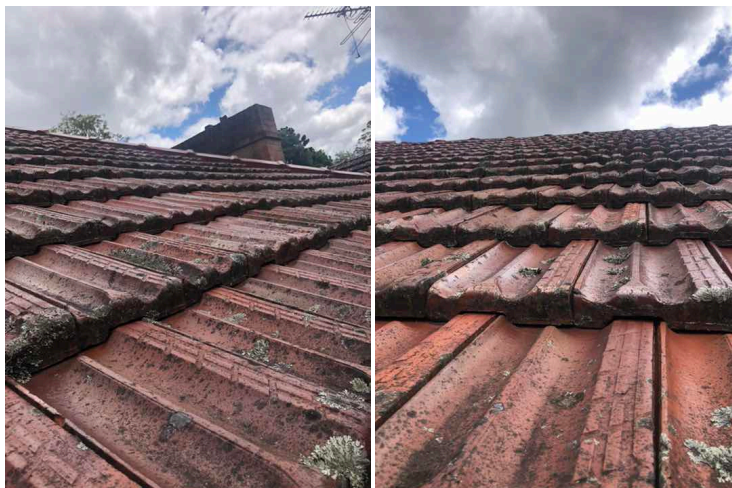
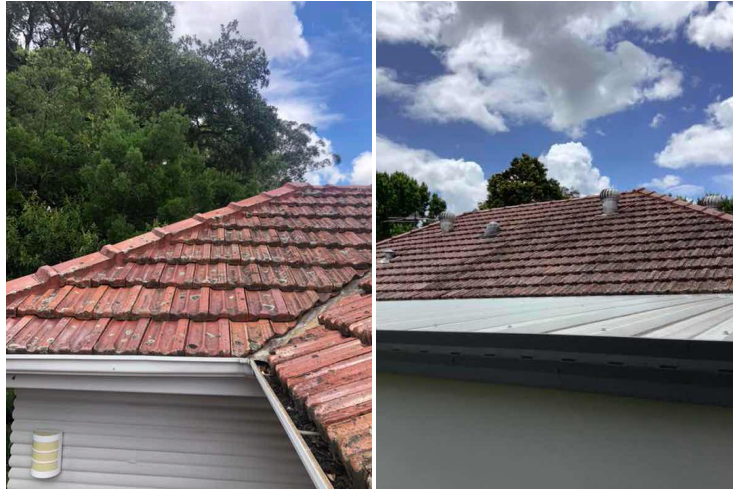
Roof Covering Condition

Visible section of The roof cladding appeared in a serviceable condition for the age of this dwelling. Annual maintenance inspection recommended.

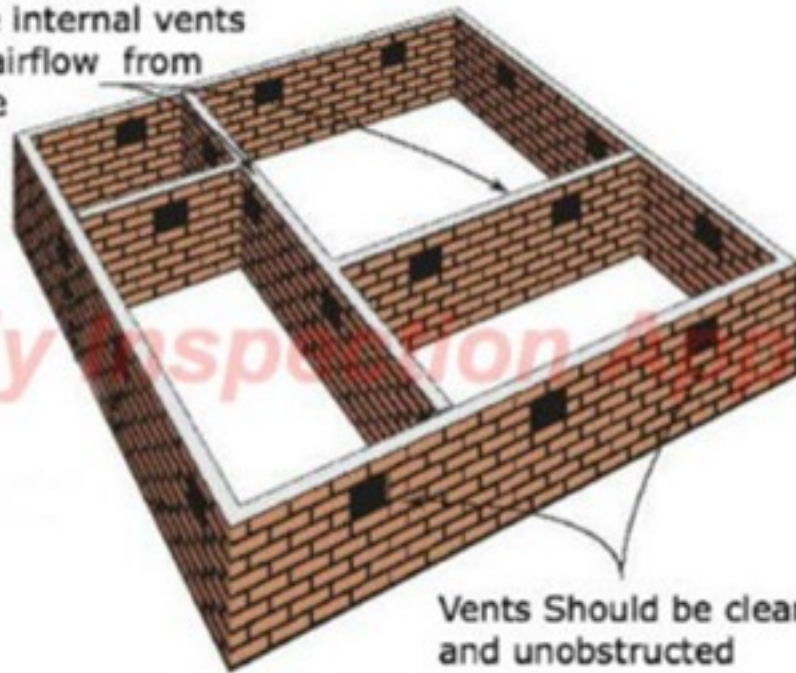
The vents are unobstructed.

Vents Should be clear
and unobstructed

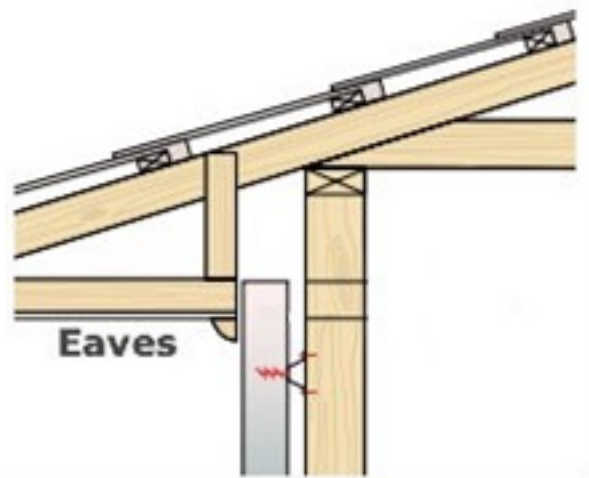
The eaves are in a serviceable condition with no notable defects.

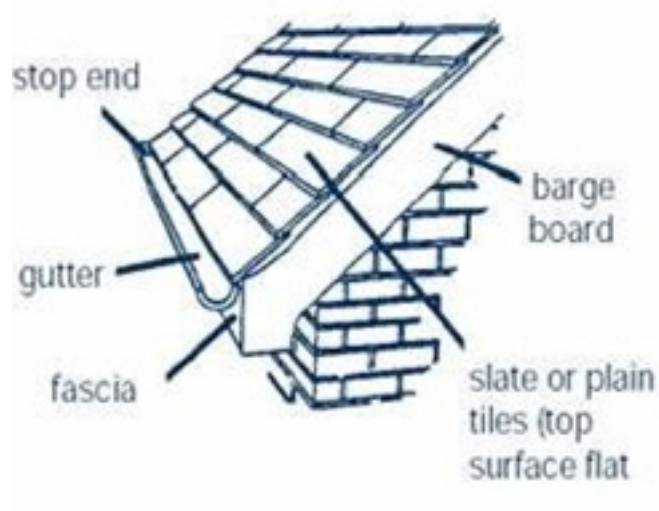
On visual inspection, the general condition of the fascia/barge boards is serviceable.

These timbers due to their position are prone to decay and should be kept well painted to prevent such deterioration.

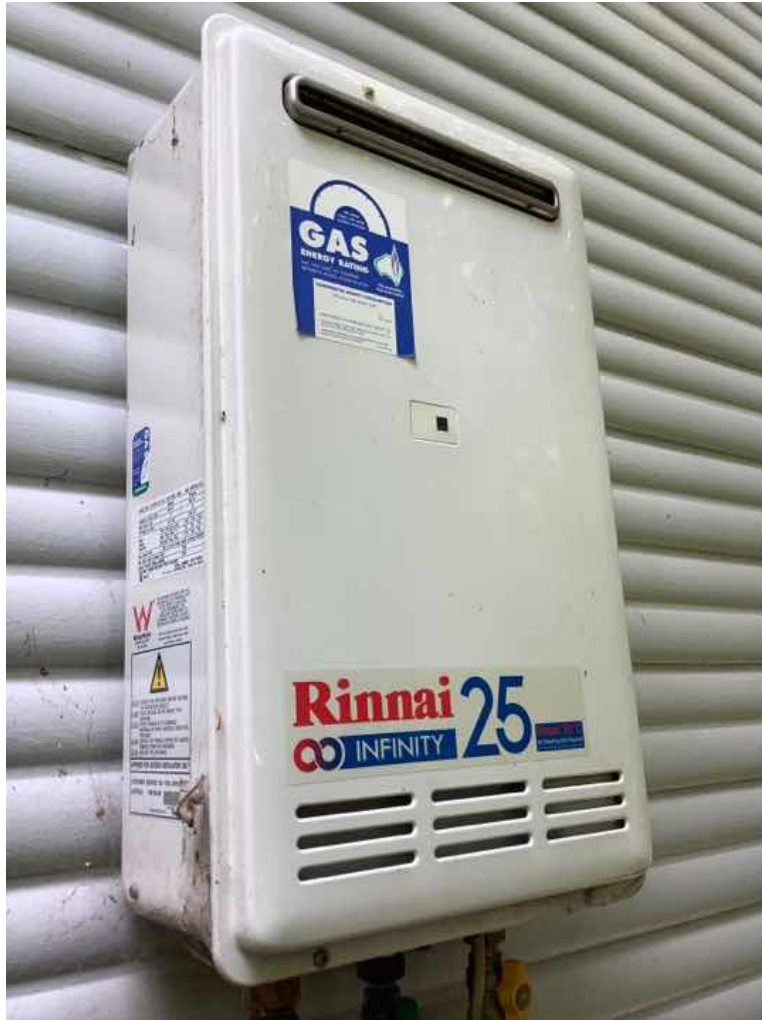
The hot water system appears to be in a serviceable condition. No specific tests other than running the hot water from a tap was carried out. No determination has been made as to the suitability or adequacy of the hot water system in relation to capacity or otherwise.

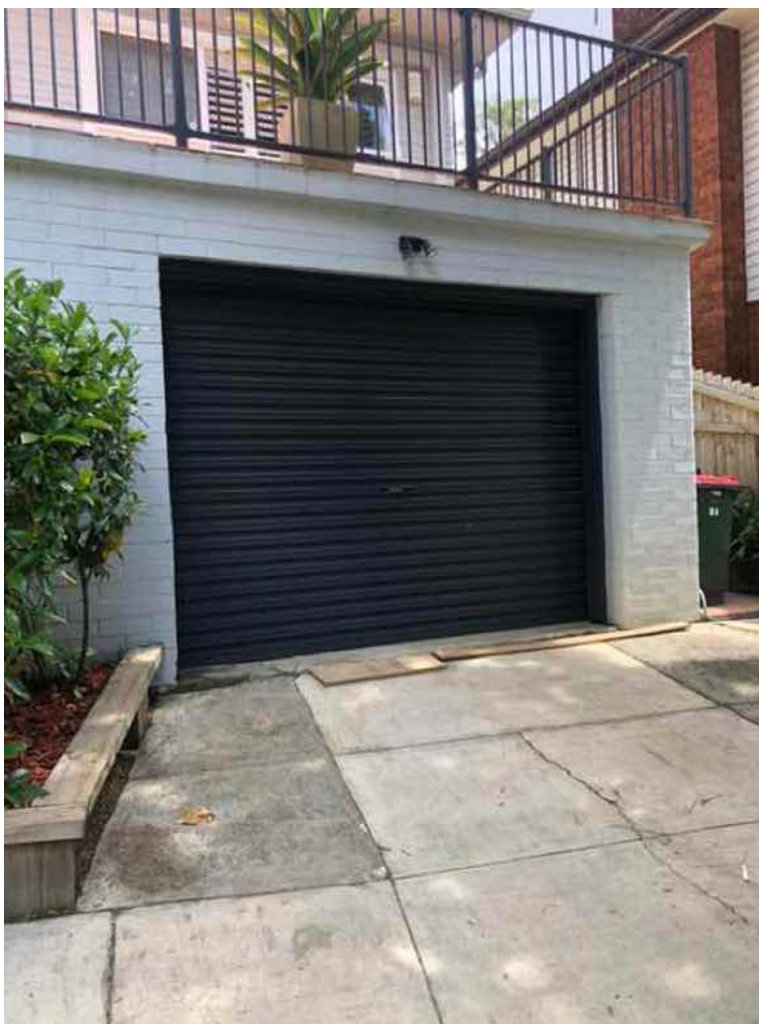
Of accessible and visible areas, the garaging is considered to be in a serviceable condition.

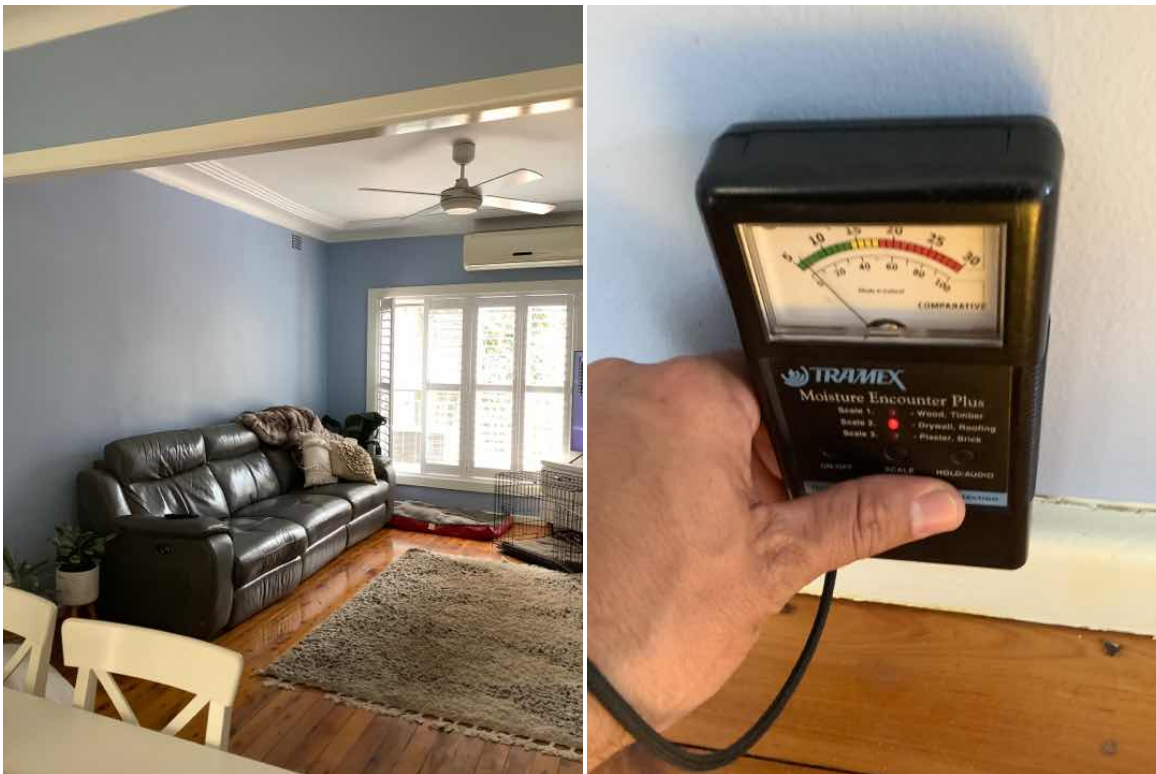
Patching was visible to the ceiling/walls, however further repairs are optional.

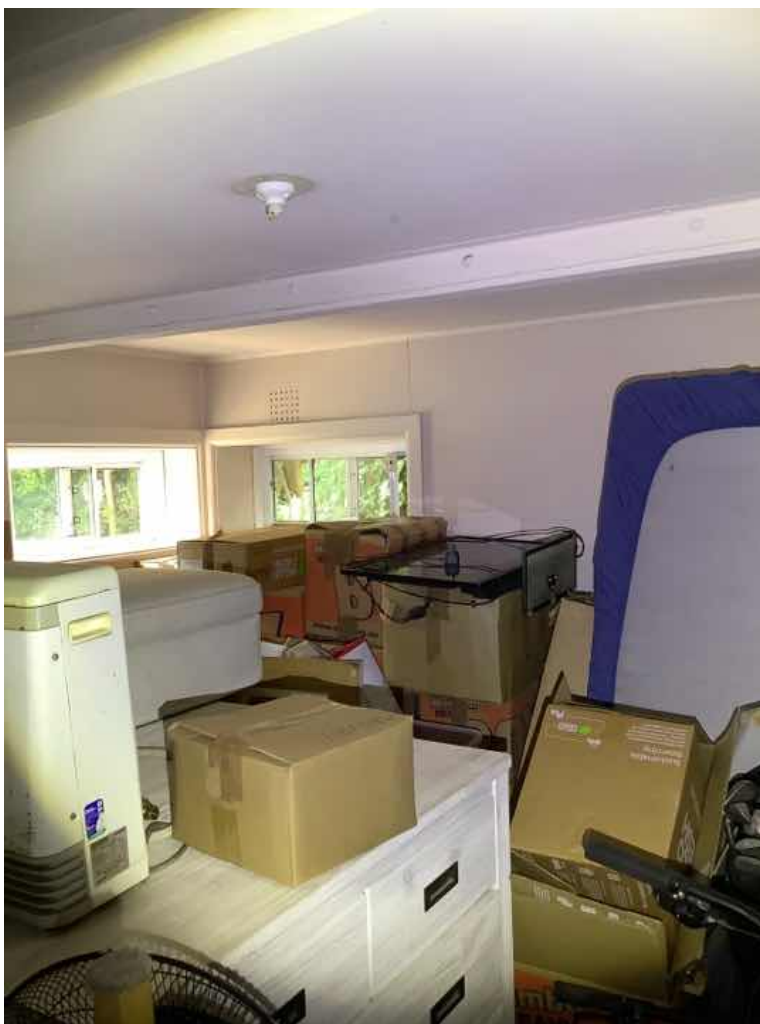
Minor cracking is evident to the wall finishes which should patch and paint successfully if repairs are carried out in a tradelike manner.

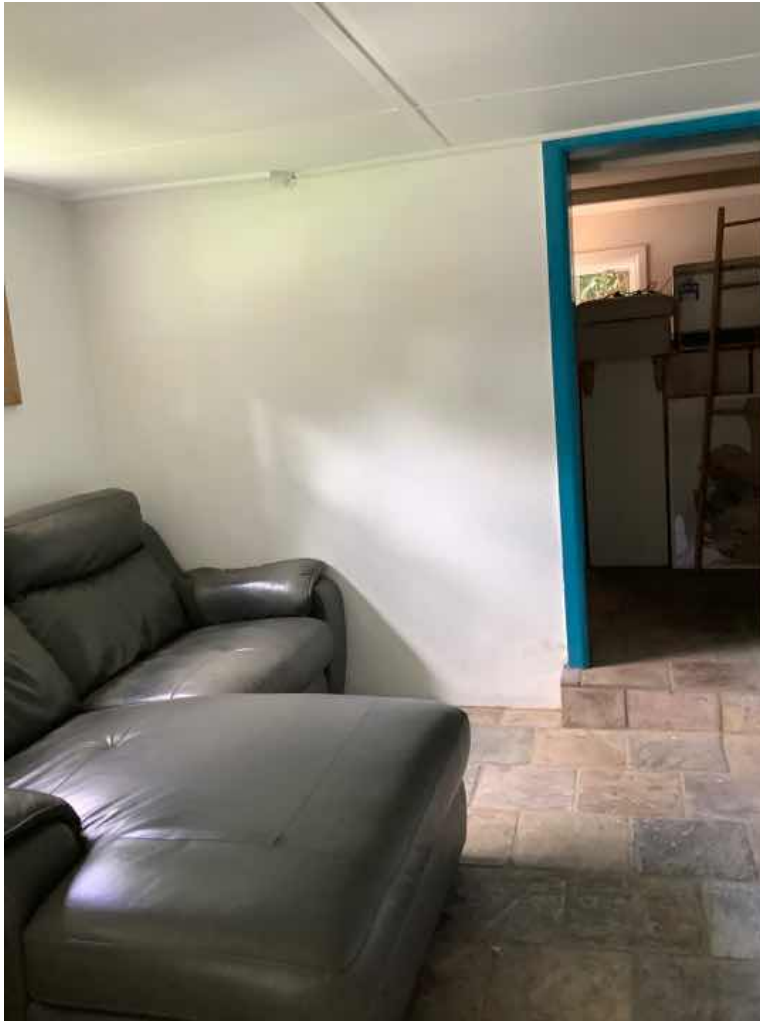
Moderate to high moisture readings were detected to on wall possibly due to lack of a suitable damp course, lack of ventilation to subfloor areas, or inadequate surface drainage to external perimeters. Rectification is required to prevent future deterioration.

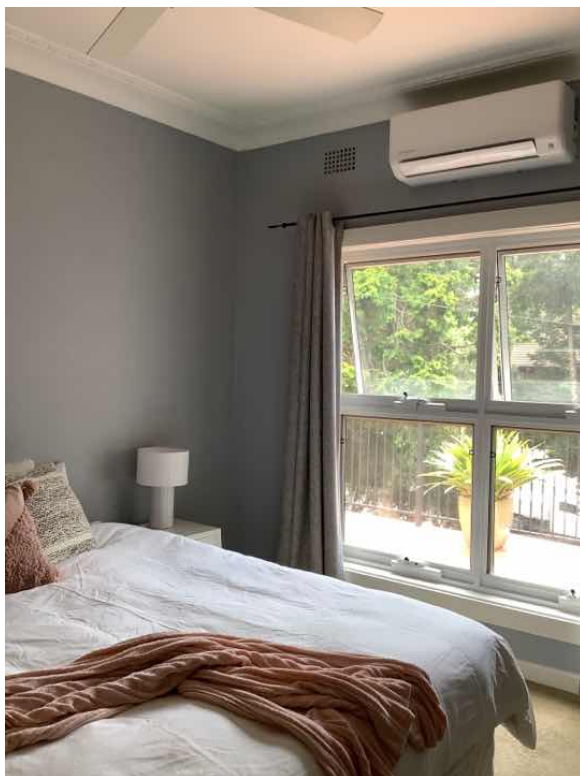
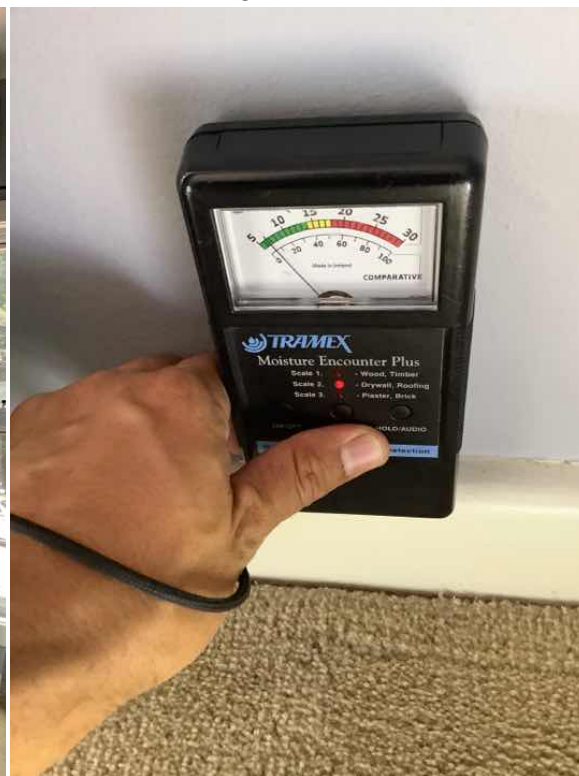
Bedroom 2

Minor cracking is evident to the wall finishes which should patch and paint successfully if repairs are carried out in a tradelike manner.

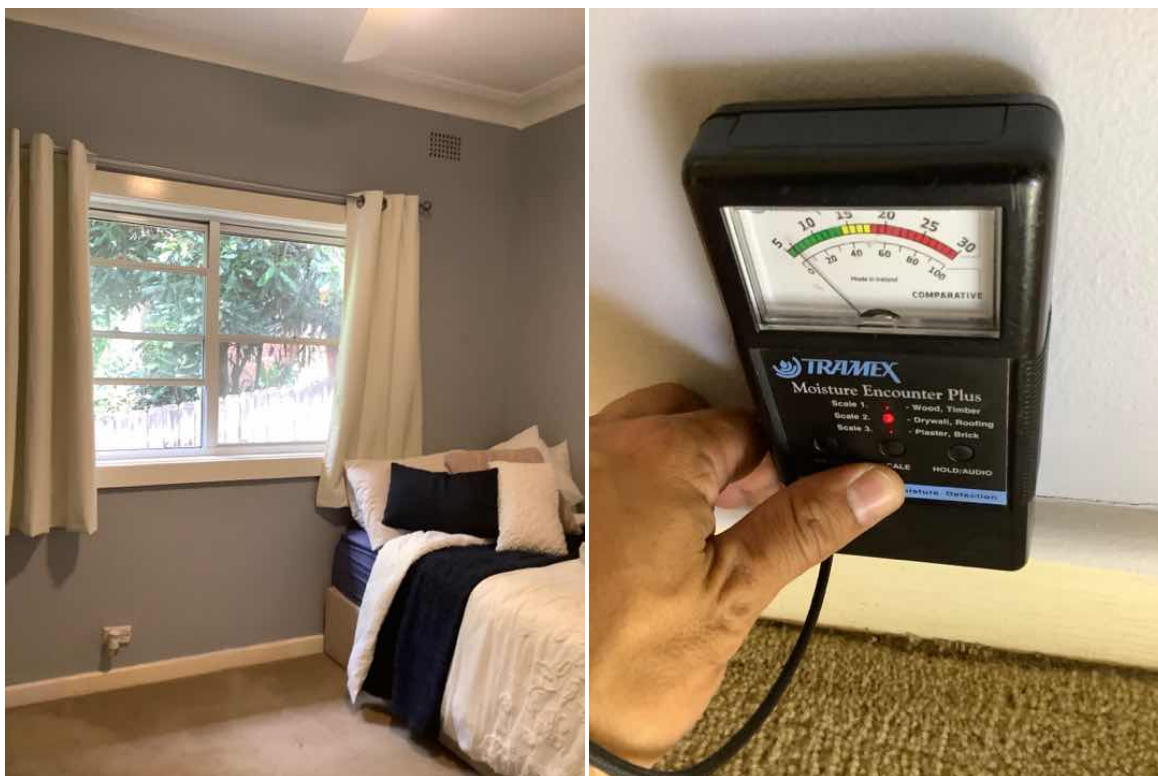
Moisture reading

High Moisture

It should be noted the lower level rooms are prone to moisture problems due to having been built below the ground. These areas should be monitored for signs of deterioration.

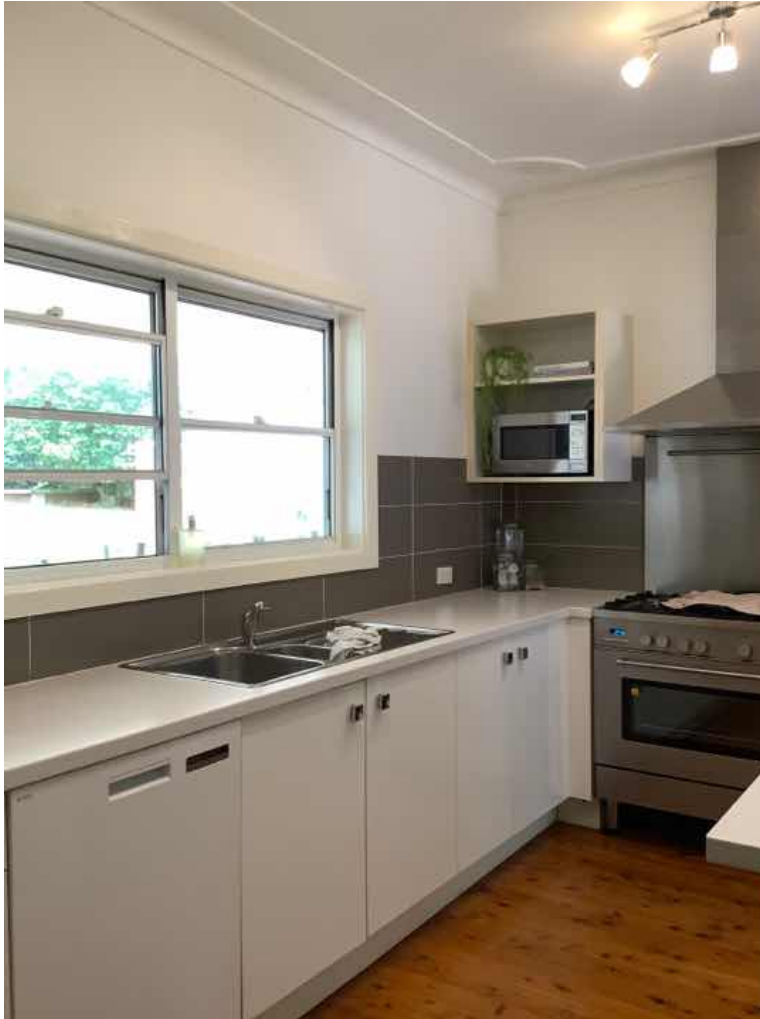
Bench top and splash back junction sealing deteriorated - Recommendations: Re-sealing by a plumber or general maintenance contractor is recommended to prevent water access behind the bench.

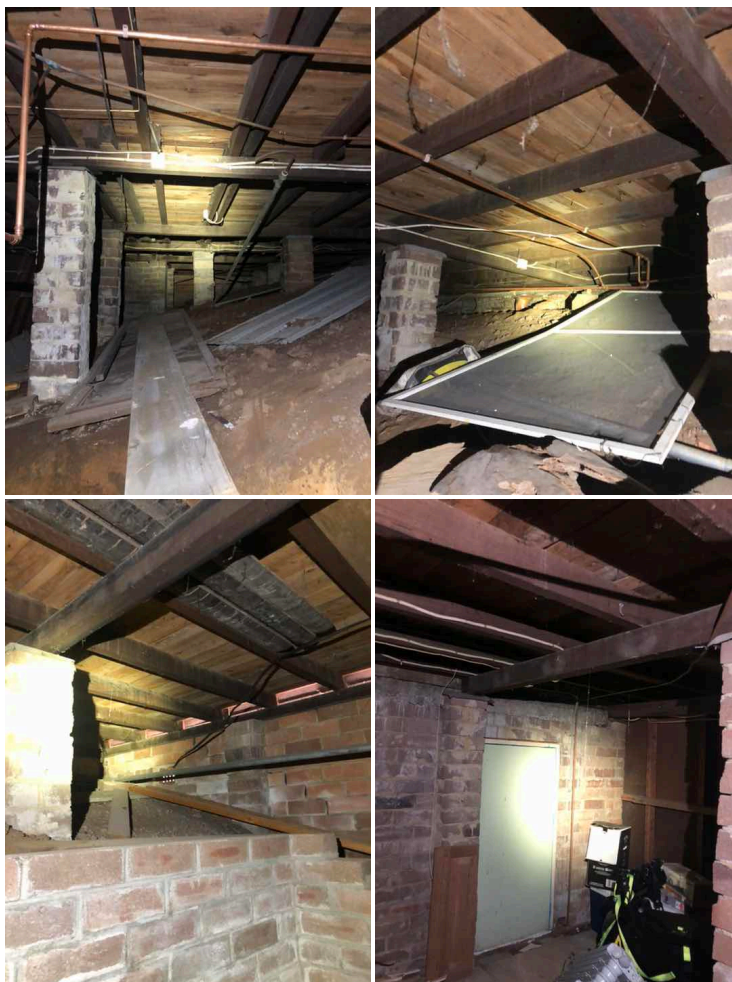
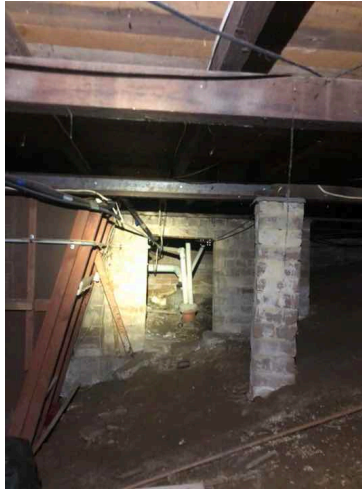
Of areas accessible and visible, the subfloor and components appeared to be in a serviceable condition.

Though dry at the time of inspection there is evidence of previous water ingress in sub floor due to natural topography. This is likely to happen again during periods of heavy rain. Further assessment and rectification is required as this may cause possibly create/add further footings problems and settlement to piers.
