PRE PURCHASE PROPERTY INSPECTION

8 Burgan Place, North Lakes.

Visual Pre Purchase Building & Timber Pest Inspection Report

To comply with Australian Standard AS4349.1-2007 and AS4349.3-2010

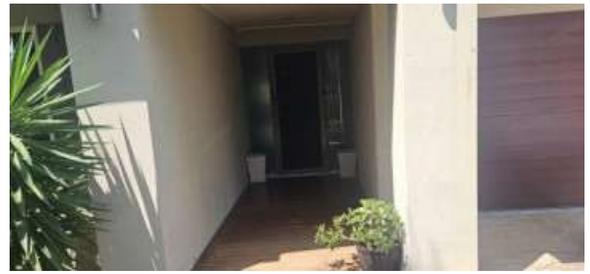
Under the main roof.
Constructed from timber. The general condition of this structure is fair.

Defects Or Maintenance Items:
Age and weathering noted and repairs required.

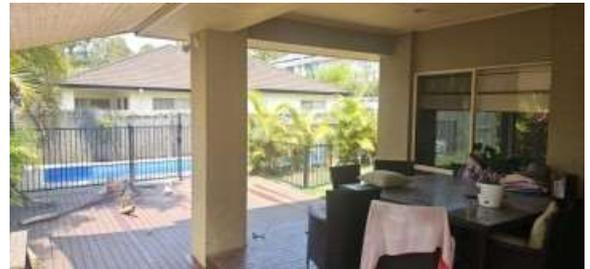
REAR DECK

Defects Or Maintenance Items:
Mould was noted to the eaves lining. The cause of this mould should be further investigated by an expert in mould detection and analysis. Recommend a specialist be commissioned to report on all mould present to this property.

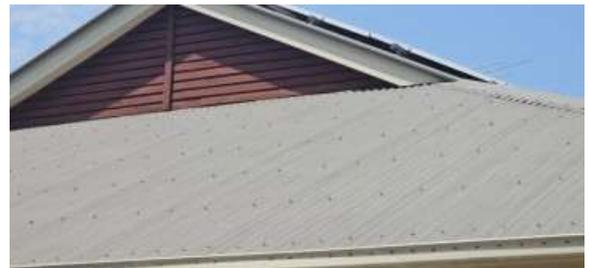
The overall condition of the roof coverings is fair.

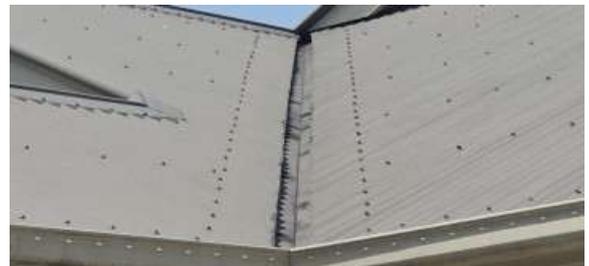
The overall condition of the roof coverings is fair.

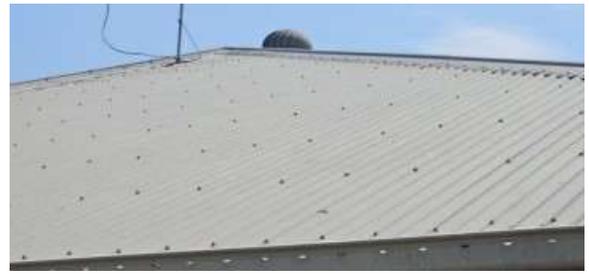
The overall condition of the roof coverings is fair.

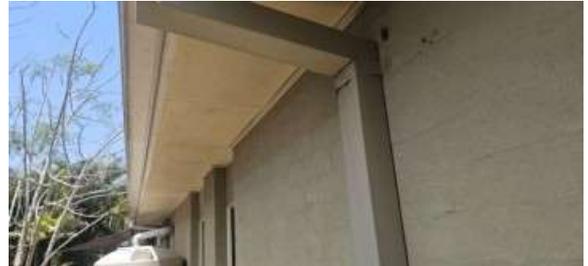
Mould was noted to the eaves lining. The cause of this mould should be further investigated by an expert in mould detection and analysis. Recommend a specialist be commissioned to report on all mould present to this property.
Water is ponding in the gutters and they require realigning.

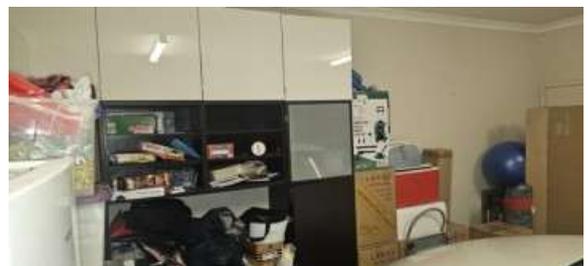
Stored items restricted inspection to the interior. These goods must be removed to enable a more complete report to be submitted. The structure is fully lined preventing inspection to all framing timbers.

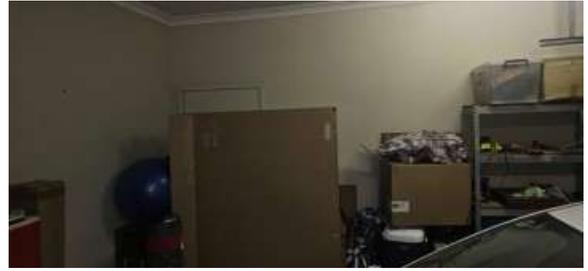
Stored items restricted inspection to the interior. These goods must be removed to enable a more complete report to be submitted.

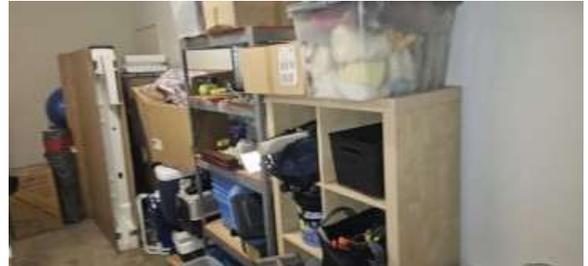
Stored items restricted inspection to the interior. These goods must be removed to enable a more complete report to be submitted. The structure is fully lined preventing inspection to all framing timbers.

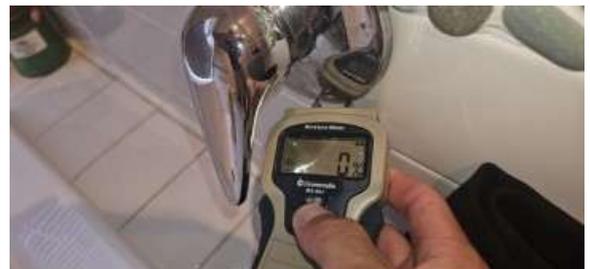
The bath appears to be in fair condition. The area will need to be kept well sealed to prevent water penetration to surrounding areas.

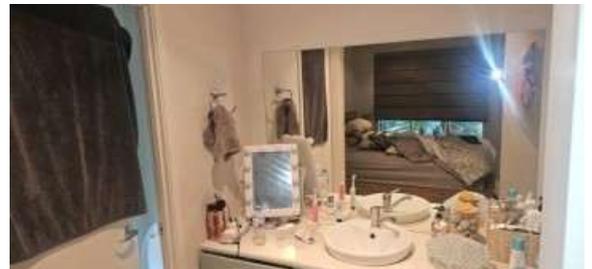
ENSUITE BATHROOM:**Room Location:**

The shower recess was tested and there was no visible water penetration to surrounding areas. **IMPORTANT NOTE:** This test may not reveal water leaks until the shower is put into constant use and surrounding areas monitored over a period of time. Junction of wall finish and shower base should be resealed appropriately to prevent water entry to wall cavity.

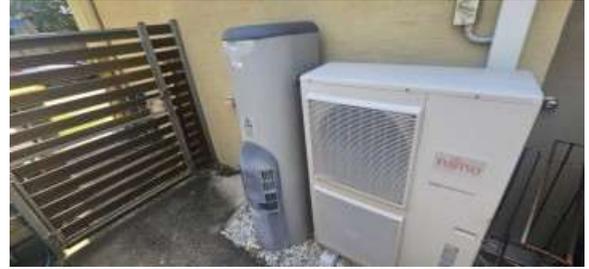
Type/Condition:

The hot water system appears to be in working condition. No specific tests other than running the hot water tap were carried out. No determination has been made as to the suitability or adequacy of the hot water system in relation to capacity or otherwise.

We were unable to determine the age of the unit.

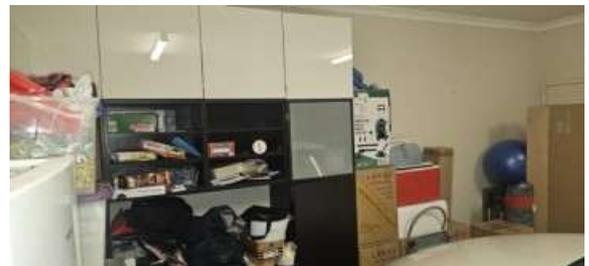
Stored items restricted inspection to the interior. These goods must be removed to enable a more complete report to be submitted. The structure is fully lined preventing inspection to all framing timbers.

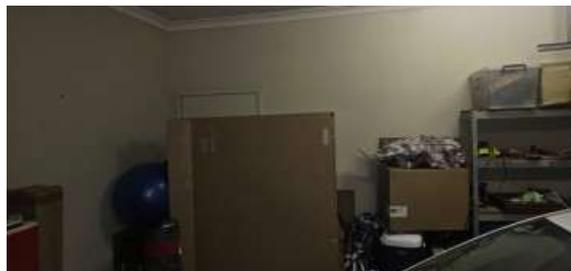
Stored items restricted inspection to the interior. These goods must be removed to enable a more complete report to be submitted.

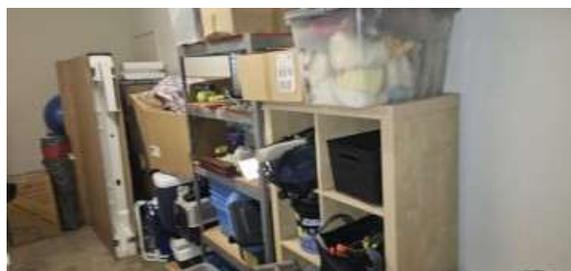
Stored items restricted inspection to the interior. These goods must be removed to enable a more complete report to be submitted. The structure is fully lined preventing inspection to all framing timbers.

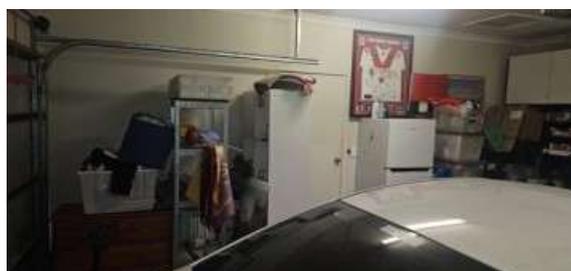
The structure is partially lined preventing inspection to some framing timbers. Inspection to sections of the exterior was restricted due to the stored goods. These goods must be removed to enable a more complete report to be submitted.

Active termites or other timber damaging pests may be present and not detected in areas where inspection was limited, obstructed or access was not gained. Recommend access be gained.

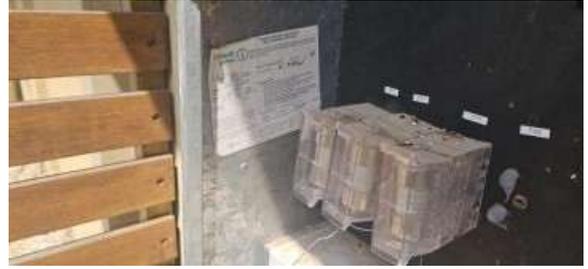
A notice indicates that the property may have been treated during construction in respect to protection against subterranean termite attack. We strongly recommend any prospective purchaser attempt to verify this information and obtain copies of all relevant documentation.
