702/180 Livingstone Rd, Marrickville NSW 2204

# STRATA REPORT

**702/180 Livingstone Rd, Marrickville NSW 2204**

## Preliminary Major Building Defects Report

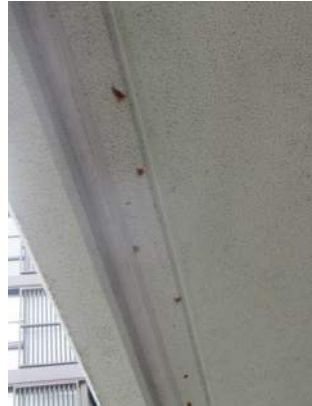
| Item | Area | Defect | Substantiation | Actions | Defect Photograph |
|---|---|---|---|---|---|
| SOU. B.0006 | Building B Unit 207 Balcony Soffit | Corrosion of ferrous material at surface of soffit due to inadequate concrete prep or reinforcement coverage. | <p>The Builder has failed to provide sufficient concrete coverage to embedded steel when the slab was constructed as per AS3600:Concrete Structures.</p> <p>The author considers the recorded defects to be non-compliant with the following statutory requirements:<br/> HBA Part 2C clause 18B(a) breach: 'a warranty that the work will be done with due care and skill and in accordance with the plans and specifications set out in the contract,<br/> HBA Part 2C clause 18B(c) breach: 'a warranty that the work will be done in accordance with, and will comply with, this or any other law'; and</p> <p>The defects also represent failures by the Builder to comply with one of, or a combination of the following:<br/> BCA SECTION B STRUCTURE – PART B1 STRUCTURAL PROVISIONS: FUNCTIONAL STATEMENTS BF1.1:<br/> A building or structure is to withstand the combination of loads and other actions to which it may be reasonably subjected.<br/> BCA SECTION B STRUCTURE – PART B1 STRUCTURAL PROVISIONS: DEEMED-TO-SATISFY PROVISIONS: B1.4: DETERMINATIO OF STRUCTURAL RESISTANCE OF MATERIALS ANF FORMS OF CONSTRUCTION:<br/> The structural resistance of materials and forms of construction must be determined in accordance with the following, as appropriate:<br/> (a) Concrete:<br/> (i) Concrete construction (including reinforced and prestressed concrete): AS3600.</p> | Break out concrete, remove corroded ferrous material, treat with zinc rich primer (minimum 28%), patch using non shrink repair mortar. Reinstate painted coating to the soffit to match the existing to the nearest architectural break. | <p>IMG_1555.JPG 1/05/25 12:58 PM</p> |

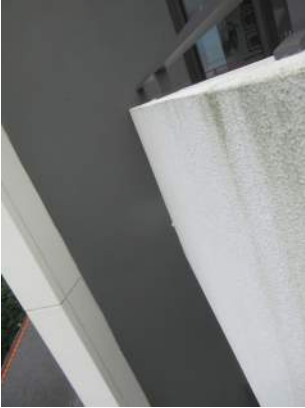
| Item | Area | Defect | Substantiation | Actions | Defect Photograph |
|---|---|---|---|---|---|
| SOU. B.0017 | Building B Unit 702 Balcony | Balcony overflow drain concealed by finished floor level of the tiles. | <p>The Builder has failed to provide adequate provision for overflow of the drainage system to the balcony.</p> <p>The author considers the recorded defects to be non-compliant with the following statutory requirements:<br/> HBA Part 2C clause 18B(a) breach: 'a warranty that the work will be done with due care and skill and in accordance with the plans and specifications set out in the contract; and<br/> HBA Part 2C clause 18B(c) breach: 'a warranty that the work will be done in accordance with, and will comply with, this or any other law'.</p> <p>The defects also represent failures by the Builder to comply with one of, or a combination of the following:<br/> BCA SECTION F HEALTH AND AMENITY – PART F1 DAMP AND WEATHERPROOFING: FUNCTIONAL STATEMENTS FF1.2:<br/> <i>A building is to be constructed to provide resistance to moisture penetration from the outside including rising from the ground.</i><br/> BCA SECTION F HEALTH AND AMENITY – PART F1 DAMP AND WEATHERPROOFING: Performance Requirement FP1.3:<br/> <i>A drainage system for the disposal of surface water must –<br/> (a) convey surface water to an appropriate outfall; and<br/> (b) undue dampness or deterioration of building elements.</i><br/> BCA SECTION F HEALTH AND AMENITY – PART F1 DAMP AND WEATHERPROOFING: Deemed-to-Satisfy Provisions F1.1:<br/> <i>Stormwater drainage must comply with AS3500.3</i></p> | Install overflow provision to the balcony at height greater than the f.f.l. and primary drainage outlet and lesser than the waterproofing termination height at the balcony doors. Overflow is to be incorporated into the waterproof membrane system as per the requirements of AS4654.2. | <p>IMG_1702.JPG 1/05/25 3:35 PM</p> |

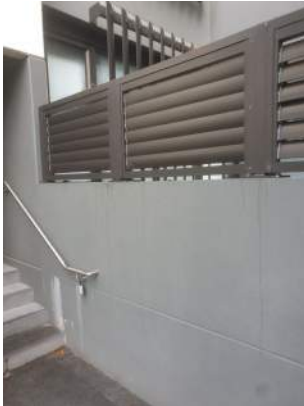
| Item | Area | Defect | Substantiation | Actions | Defect Photograph |
|---|---|---|---|---|---|
| CA. A1.000 2 | Building A1 Ground Level Adjacent North Eastern Fire Escape Unit 109 Balcony | Efflorescence in wall joint indicating potential failure of the Unit 109 courtyard waterproofing membrane. Weatherproofing of the wall has failed. | <p>Further investigations are required to verify the presence of the alleged defect.</p> <p>Further investigations were conducted on the 7/10/25. The efflorescence emanating from the control joint in the wall exists above the waterproofing termination of the adjacent balcony. The joint sealant to the left of the of the wall panel and to the base has failed and is allowing for water ingress and egress between the panels creating the efflorescence. The weatherproofing to the wall has failed and hence does not meet the requirements of AS4654.2 for weatherproof walls above waterproof membrane terminations.</p> <p>The Builder has failed to effectively weatherproof the wall above an external waterproofing system allowing for premature degradation of the building elements.</p> <p>It is the author's opinion that the Builder has breached the following warranties:</p> <p>HBA Part 2C clause 18B(a) breach: <i>'a warranty that the work will be done with due care and skill and in accordance with the plans and specifications set out in the contract,'</i></p> <p>HBA Part 2C clause 18B(b) breach: <i>'a warranty that all materials supplied by the holder or person will be good and suitable for the purpose for which they are used and that, unless otherwise stated in the contract, those materials will be new; and'</i></p> <p>HBA Part 2C clause 18B(c) breach: <i>'a warranty that the work will be done in accordance with, and will comply with, this or any other law'.</i></p> <p>The defect also represents a failure by the Builder to comply with the following requirement(s):</p> <p>BCA SECTION B STRUCTURE – PART B1 STRUCTURAL PROVISIONS: FUNCTIONAL STATEMENTS BF1.1:<br/>'A building or structure is to withstand the combination of loads and other actions to which it may be reasonably subjected.'</p> <p>BCA SECTION F HEALTH AND AMENITY – PART F1 DAMP AND WEATHERPROOFING: Deemed to Satisfy Provisions F1.4: <i>"Waterproof membranes for external above ground use must comply with AS4654 Parts 1 and 2."</i></p> | <p>Remove the failed joint sealant from around the wall panel. Install a backing rod. Reinstall the joint sealant as per manufacturers recommendations including and primers. After curing of the sealant, prepare and repaint the affected surfaces to the nearest architectural break to match existing finishes in accordance with the requirements of AS2311.</p> | <p>20250501_110228.jpg 1/05/25 11:02 AM -33.908185,151.152762</p> |

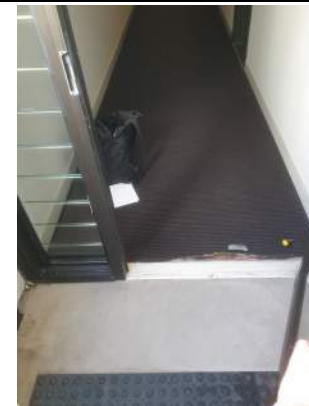
| Item | Area | Defect | Substantiation | Actions | Defect Photograph |
|---|---|---|---|---|---|
| CA.<br>A2.000<br>1 | Building A2<br>Level 10<br>Southern<br>Link<br>Doorway | Water ingress identified at the sill of the aluminium framed door associated with a lack of water shedding or drainage mechanism to the external landing. | <p>The Builder has failed to prevent water entering the building.</p> <p>It is the author's opinion that the Builder has breached the following warranties:</p> <p>HBA Part 2C clause 18B(a) breach: 'a warranty that the work will be done with due care and skill and in accordance with the plans and specifications set out in the contract';</p> <p>HBA Part 2C clause 18B(c) breach: 'a warranty that the work will be done in accordance with, and will comply with, this or any other law'; and</p> <p>HBA Part 2C clause 18B(e) breach: 'a warranty that, if the work consists of the construction of a dwelling, the making of alterations or additions to a dwelling or the repairing, renovation, decoration or protective treatment of a dwelling, the work will result, to the extent of the work conducted, in a dwelling that is reasonably fit for occupation as a dwelling'.</p> <p>The defect also represents a failure by the Builder to comply with the following requirement(s):</p> <ul style="list-style-type: none"> <li>• BCA SECTION F HEALTH AND AMENITY – PART F1 DAMP AND WEATHERPROOFING: FUNCTIONAL STATEMENTS FF1.2:<br/>A building is to be constructed to provide resistance to moisture penetration from the outside including rising from the ground.</li> <li>• BCA - SECTION F HEALTH AND AMENITY - Part F1 DAMP AND WEATHERPROOFING: PERFORMANCE REQUIREMENTS FP:1.4:<br/>'A roof and external wall (incl openings around windows and doors) must prevent the penetration of water that could cause:<br/>(a) unhealthy or dangerous conditions, or loss of amenity to occupants, and<br/>(b) undue dampness or deterioration of building element'.</li> <li>• BCA SECTION F HEALTH AND AMENITY – PART F1 DAMP AND WEATHERPROOFING: Performance Requirement FP1.3:<br/>A drainage system for the disposal of surface water must –<br/>(a) convey surface water to an appropriate outfall; and<br/>(b) undue dampness or deterioration of building elements.</li> </ul> <p>AS 2047 – SECTION 7 INSTALLATION; 7.2 INSTALLATION; 7.2.2 FLASHING:<br/>'Flashing shall be incorporated into the building envelope where it is necessary— (a) to restrict water from entering into the interior of a building from the exterior; (b) to restrict water passing across a cavity to the inner leaf; or (c) to shed water through cladding to the outer face'.</p> <p>AS 4654.2 – SECTION 2 DESIGN AND INSTALLATION; 2.8 TERMINATION OF MEMBRANES; 2.8.3 DOORS AND WINDOWS ONTO EXTERNAL WATERPROOFED AREAS:<br/>'For doors and windows onto external waterproofed areas, the following apply:<br/>(a) Sub-sill flashings shall be included as part of the membrane system.<br/>(b) Where the internal and external finished floor levels do not allow an upturn, the membranes shall be fixed under the sill and terminate into the stormwater system'.</p> | Create water stop at door sill and correct falls to external landing so water drains away from door sill. All works to be incorporated with the associated external waterproof membrane in accordance with AS4654.2 where applicable. | <p>20250501_094306.jpg 1/05/25 9:43 AM -33.907945,151.152790</p> |

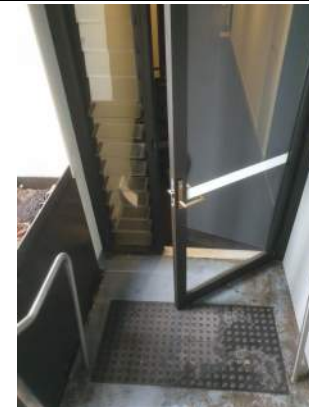
| Item | Area | Defect | Substantiation | Actions | Defect Photograph |
|---|---|---|---|---|---|
| CA.<br>A2.000<br>2 | Building A2<br>Level 3<br>Southern<br>Link<br>Doorway | Door frame has dropped leaving door unable to open and door latch unable to be secured. | <p>The Builder has failed to provide effective access and egress from the building the building.</p> <p>It is the author's opinion that the Builder has breached the following warranties:</p> <p>HBA Part 2C clause 18B(a) breach: 'a warranty that the work will be done with due care and skill and in accordance with the plans and specifications set out in the contract';</p> <p>HBA Part 2C clause 18B(b) breach: 'a warranty that all materials supplied by the holder or person will be good and suitable for the purpose for which they are used and that, unless otherwise stated in the contract, those materials will be new';</p> <p>HBA Part 2C clause 18B(c) breach: 'a warranty that the work will be done in accordance with, and will comply with, this or any other law'; and</p> <p>HBA Part 2C clause 18B(e) breach: 'a warranty that, if the work consists of the construction of a dwelling, the making of alterations or additions to a dwelling or the repairing, renovation, decoration or protective treatment of a dwelling, the work will result, to the extent of the work conducted, in a dwelling that is reasonably fit for occupation as a dwelling'.</p> <p>The defect also represents a failure by the Builder to comply with the following requirement(s):</p> <p>BCA SECTION D ACCESS AND EGRESS – PART DP1:<br/>Access must be provided, to the degree necessary, to enable –<br/>(a) People to –<br/>... (ii) approach the building from any accessible associated building ...</p> <p>BCA SECTION D ACCESS AND EGRESS – PART DP2:<br/>So that people can move safely to and within a building, it must have –<br/>... (b) any doors installed to avoid risk of occupants –<br/>(i) Having their egress impeded; or<br/>(ii) Being trapped in the building...</p> | Realign door frame to fit the jamb and create clearance from the landing below and allow the latch to operate correctly. | <p>20250501_101724.jpg 1/05/25 10:17 AM -33.908202,151.153824</p> |

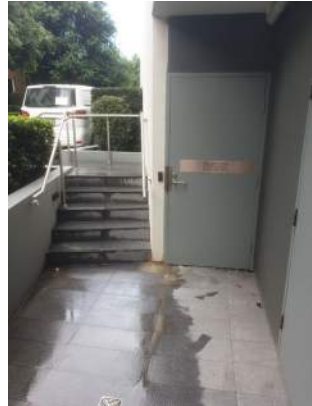
| Item | Area | Defect | Substantiation | Actions | Defect Photograph |
|---|---|---|---|---|---|
| CA.<br>A2.000<br>5 | Building A2<br>Ground<br>Level<br>Eastern<br>Carpark<br>Fire<br>Escape<br>Door<br>External<br>Stairs | Efflorescence leaching from stair to wall abutment and tracking beneath wall into staircase associated with a failure of the waterproofing detail between the elements. | <p>The Builder has failed to prevent water entering the car parks fire escape.</p> <p>It is the author's opinion that the Builder has breached the following warranties:</p> <p>HBA Part 2C clause 18B(a) breach: 'a warranty that the work will be done with due care and skill and in accordance with the plans and specifications set out in the contract';</p> <p>HBA Part 2C clause 18B(c) breach: 'a warranty that the work will be done in accordance with, and will comply with, this or any other law'; and</p> <p>HBA Part 2C clause 18B(e) breach: 'a warranty that, if the work consists of the construction of a dwelling, the making of alterations or additions to a dwelling or the repairing, renovation, decoration or protective treatment of a dwelling, the work will result, to the extent of the work conducted, in a dwelling that is reasonably fit for occupation as a dwelling'.</p> <p>The defect also represents a failure by the Builder to comply with the following requirement(s):</p> <ul style="list-style-type: none"> <li>• BCA SECTION F HEALTH AND AMENITY – PART F1 DAMP AND WEATHERPROOFING: FUNCTIONAL STATEMENTS FF1.2:<br/>A building is to be constructed to provide resistance to moisture penetration from the outside including rising from the ground.</li> <li>• BCA - SECTION F HEALTH AND AMENITY - Part F1 DAMP AND WEATHERPROOFING: PERFORMANCE REQUIREMENTS FP.1.4:<br/>'A roof and external wall (incl openings around windows and doors) must prevent the penetration of water that could cause.</li> <li>(a) unhealthy or dangerous conditions, or loss of amenity to occupants, and</li> <li>(b) undue dampness or deterioration of building element'.</li> <li>• BCA - SECTION F HEALTH AND AMENITY - Part F1 DAMP AND WEATHERPROOFING: PERFORMANCE REQUIREMENTS F1.4:<br/>Waterproofing membranes for external above ground use must comply with AS 4654 Parts 1 and 2.</li> </ul> | Remove abutting tiles and screed and repair waterproofing membrane to comply with the requirements of AS4654.2. Reinstall finishes. | <p>20250501_103159.jpg 1/05/25 10:31 AM</p> |

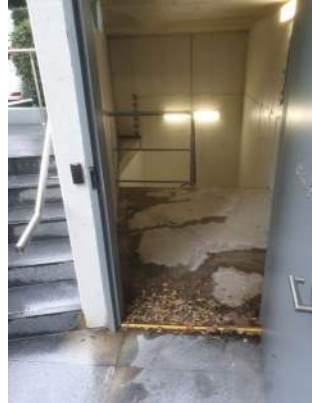
| Item | Area | Defect | Substantiation | Actions | Defect Photograph |
|---|---|---|---|---|---|
| CA.<br>A2.000<br>6 | Building A2<br>Ground<br>Level<br>Eastern<br>Carpark<br>Fire<br>Escape<br>Landing | Water ingress identified at the sill of the aluminium framed door associated with a lack of water shedding or drainage mechanism to the external landing. | <p>The Builder has failed to prevent water entering the building.</p> <p>It is the author's opinion that the Builder has breached the following warranties:</p> <p>HBA Part 2C clause 18B(a) breach: 'a warranty that the work will be done with due care and skill and in accordance with the plans and specifications set out in the contract';</p> <p>HBA Part 2C clause 18B(c) breach: 'a warranty that the work will be done in accordance with, and will comply with, this or any other law'; and</p> <p>HBA Part 2C clause 18B(e) breach: 'a warranty that, if the work consists of the construction of a dwelling, the making of alterations or additions to a dwelling or the repairing, renovation, decoration or protective treatment of a dwelling, the work will result, to the extent of the work conducted, in a dwelling that is reasonably fit for occupation as a dwelling'.</p> <p>The defect also represents a failure by the Builder to comply with the following requirement(s):</p> <ul style="list-style-type: none"> <li>• BCA SECTION F HEALTH AND AMENITY – PART F1 DAMP AND WEATHERPROOFING: FUNCTIONAL STATEMENTS FF1.2:<br/>A building is to be constructed to provide resistance to moisture penetration from the outside including rising from the ground.</li> <li>• BCA - SECTION F HEALTH AND AMENITY - Part F1 DAMP AND WEATHERPROOFING: PERFORMANCE REQUIREMENTS FP.1.4:<br/>'A roof and external wall (incl openings around windows and doors) must prevent the penetration of water that could cause.<br/>(a) unhealthy or dangerous conditions, or loss of amenity to occupants, and<br/>(b) undue dampness or deterioration of building element'.</li> <li>• BCA SECTION F HEALTH AND AMENITY – PART F1 DAMP AND WEATHERPROOFING: Performance Requirement FP1.3:<br/>A drainage system for the disposal of surface water must –<br/>(a) convey surface water to an appropriate outfall; and<br/>(b) undue dampness or deterioration of building elements.</li> </ul> <p>AS 2047 – SECTION 7 INSTALLATION; 7.2 INSTALLATION; 7.2.2 FLASHING:<br/>'Flashing shall be incorporated into the building envelope where it is necessary— (a) to restrict water from entering into the interior of a building from the exterior; (b) to restrict water passing across a cavity to the inner leaf; or (c) to shed water through cladding to the outer face'.</p> <p>AS 4654.2 – SECTION 2 DESIGN AND INSTALLATION; 2.8 TERMINATION OF MEMBRANES; 2.8.3 DOORS AND WINDOWS ONTO EXTERNAL WATERPROOFED AREAS:<br/>'For doors and windows onto external waterproofed areas, the following apply:<br/>(a) Sub-sill flashings shall be included as part of the membrane system.<br/>(b) Where the internal and external finished floor levels do not allow an upturn, the membranes shall be fixed under the sill and terminate into the stormwater system'.</p> | Create water stop at door sill and correct falls to external landing so water drains away from door sill. If this is not possible, introduce grated strip drain to the threshold. All works to be incorporated with the associated external waterproof membrane in accordance with AS4654.2. | <p>20250501_103219.jpg 1/05/25 10:32 AM -33.907714,151.153317</p> |

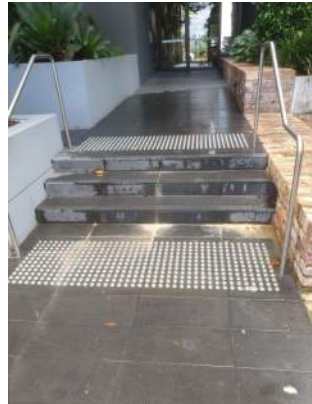
| Item | Area | Defect | Substantiation | Actions | Defect Photograph |
|---|---|---|---|---|---|
| CA.<br>A2.000<br>7 | Building A2<br>Ground<br>Level<br>Building A<br>Eastern<br>Entry Stairs | Efflorescence leaching from beneath the tiled concrete stairs associated with either failure of the waterproof membrane system or inadequate detailing of the membrane system. | <p>The cause of the efflorescence couldn't be substantiated at the time of inspection. Destructive investigation is required to determine the construction detail and to determine whether a defect is present.</p> <p>Following review of additional supplied plans and documentation we have determined that the location of this defect corresponds with water ingress to the carpark below identified under item CP.0001 of the Building Defect Schedule. The water ingress below through the slab infill above the disabled parking bays confirms a failure of the waterproof membrane at this location and the tiled finishes will need to be removed to conduct the required waterproofing repairs. We could not at the time of inspection justify removal of the tiled finishes and risking further damage to the already compromised waterproof membrane and risk further water ingress creating additional safety issues to the disabled parking area below.</p> | We recommend destructive on-site investigations are completed. | <p>20250501_110451.jpg 1/05/25 11:04 AM -33.907995,151.153164</p> |

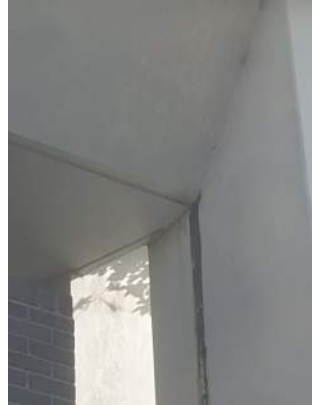
| Item | Area | Defect | Substantiation | Actions | Defect Photograph |
|---|---|---|---|---|---|
| CA.<br>B.0001 | Building B<br>Level 2<br>North<br>Eastern<br>Planter Box | Leaching from base of planter box indicating a failure of the waterproof membrane to the planter box internally. | <p>Further investigations are required to verify the presence of the alleged defect.</p> <p>Further investigations were conducted on the 7/10/25. A localised water test was conducted by way of introducing water to the planter of the corresponding Unit 202 above. Within approximately 20 minutes water could be seen running down the wall beneath the planter box.</p> <p>The Builder has failed to effectively waterproof the planter box and prevent the penetration of water through structural concrete elements.</p> <p>It is the author's opinion that the Builder has breached the following warranties:</p> <p>HBA Part 2C clause 18B(a) breach: 'a warranty that the work will be done with due care and skill and in accordance with the plans and specifications set out in the contract';</p> <p>HBA Part 2C clause 18B(b) breach: 'a warranty that all materials supplied by the holder or person will be good and suitable for the purpose for which they are used and that, unless otherwise stated in the contract, those materials will be new'; and</p> <p>HBA Part 2C clause 18B(c) breach: 'a warranty that the work will be done in accordance with, and will comply with, this or any other law'.</p> <p>The defect also represents a failure by the Builder to comply with the following requirement(s):</p> <p>BCA SECTION B STRUCTURE – PART B1 STRUCTURAL PROVISIONS: FUNCTIONAL STATEMENTS BF1.1:<br/>'A building or structure is to withstand the combination of loads and other actions to which it may be reasonably subjected.'</p> <p>BCA SECTION F HEALTH AND AMENITY – PART F1 DAMP AND WEATHERPROOFING: Deemed to Satisfy Provisions F1.4: "Waterproof membranes for external above ground use must comply with AS4654 Parts 1 and 2."</p> | <p>It is not envisaged that localised repair will be feasible and that comprehensive repairs will be needed requiring regulated designs be issued under the D&amp;BPA Act. Remove the contents of the planter box. If possible, store plantings for reinstatement. Prepare the substrate and re waterproof the planter box in strict accordance with the requirements of AS4654.2 including all drainage and overflow details. Flood test the planter box for 24 hours prior to reinstatement of soil and plants and provide a report to the Owners. Reinstall soil and plants following successful flood test.</p> | <p>20250501_111557.jpg 1/05/25 11:15 AM -33.907579,151.153674</p> |

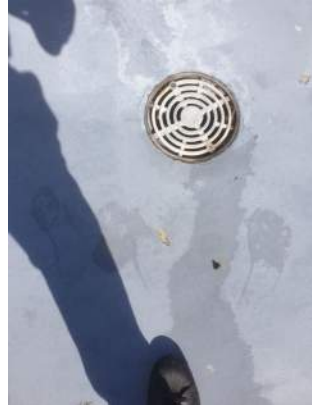
| Item | Area | Defect | Substantiation | Actions | Defect Photograph |
|---|---|---|---|---|---|
| CA.<br>B.0002 | Building B<br>Rooftop<br>Eastern<br>Central<br>Drainage<br>Outlet | Evidence of isolated waterproof membrane delamination around the drain. | <p>The Builder has failed to provide a continuous barrier impervious to water as per the requirements of AS4654.2.</p> <p>HBA Part 2C clause 18B(a) breach: 'a warranty that the work will be done with due care and skill and in accordance with the plans and specifications set out in the contract,'</p> <p>HBA Part 2C clause 18B(b) breach: 'a warranty that all materials supplied by the holder or person will be good and suitable for the purpose for which they are used and that, unless otherwise stated in the contract, those materials will be new'; and</p> <p>HBA Part 2C clause 18B(c) breach: 'a warranty that the work will be done in accordance with, and will comply with, this or any other law'.</p> <p>The defects also represent failures by the Builder to comply with one of, or a combination of the following:</p> <p>BCA SECTION F HEALTH AND AMENITY – PART F1 DAMP AND WEATHERPROOFING: FUNCTIONAL STATEMENTS FF1.2:<br/>A building is to be constructed to provide resistance to moisture penetration from the outside including rising from the ground.</p> <p>BCA - SECTION F HEALTH AND AMENITY - Part F1 DAMP AND WEATHERPROOFING: PERFORMANCE REQUIREMENTS FP:1.4:<br/>'A roof and external wall (incl openings around windows and doors) must prevent the penetration of water that could cause.</p> <p>(a) unhealthy or dangerous conditions, or loss of amenity to occupants, and</p> <p>(b) undue dampness or deterioration of building element'.</p> <p>AS 4654.2 External Waterproofing Membranes for above ground use, Part 2 Design and Installation, Section 1.3 Definitions, Clause 1.3.6 Membrane; 'An impervious barrier to liquid or water...'</p> | <p>The membrane should be locally removed and reinstated in accordance with the manufacturers specifications and to comply with the requirements of AS4654.2.</p> | <p>20250501_112354.jpg 1/05/25 11:23 AM -33.907737,151.153514</p> |

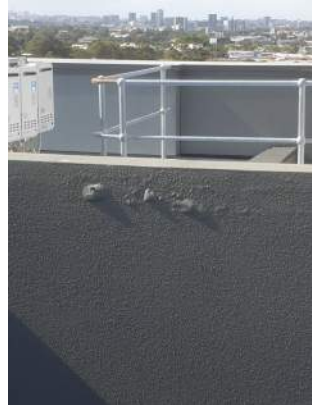
| Item | Area | Defect | Substantiation | Actions | Defect Photograph |
|---|---|---|---|---|---|
| CA.<br>B.0003 | Building B<br>Rooftop<br>Southern<br>Recess<br>Parapet<br>Walls | Water filled blisters behind the facade coating to the walls forming the southern recess above the top floor balcony indicating a failure of the wall coating. | <p>The Builder has failed to prevent water penetrating beneath the wall coating.</p> <p>HBA Part 2C clause 18B(a) breach: 'a warranty that the work will be done with due care and skill and in accordance with the plans and specifications set out in the contract,'</p> <p>HBA Part 2C clause 18B(b) breach: 'a warranty that all materials supplied by the holder or person will be good and suitable for the purpose for which they are used and that, unless otherwise stated in the contract, those materials will be new; and</p> <p>HBA Part 2C clause 18B(c) breach: 'a warranty that the work will be done in accordance with, and will comply with, this or any other law'.</p> <p>The defects also represent failures by the Builder to comply with one of, or a combination of the following:</p> <p>BCA SECTION F HEALTH AND AMENITY – PART F1 DAMP AND WEATHERPROOFING: FUNCTIONAL STATEMENTS FF1.2:<br/>A building is to be constructed to provide resistance to moisture penetration from the outside including rising from the ground.</p> <p>BCA - SECTION F HEALTH AND AMENITY - Part F1 DAMP AND WEATHERPROOFING: PERFORMANCE REQUIREMENTS FP:1.4:<br/>'A roof and external wall (incl openings around windows and doors) must prevent the penetration of water that could cause.<br/>(a) unhealthy or dangerous conditions, or loss of amenity to occupants, and<br/>(b) undue dampness or deterioration of building element'.</p> | <p>The damaged facade coating should be locally removed and the substrate allowed to dry. The wall section should then be prepared for coating in accordance with the procedures stipulated in AS2311. An elastomeric coating should then be applied to the top and both internal and external; face of the wall to the nearest control joint and or architectural break to ensure continuity of the face sealed system. Works should generally comply with the requirements of AS2311 and AS4654. All works should be done in accordance with the product manufacturers recommendations.</p> | <p>20250501_112601.jpg 1/05/25 11:26 AM -33.907750,151.153368</p> |

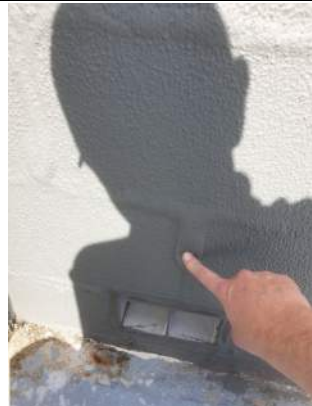
| Item | Area | Defect | Substantiation | Actions | Defect Photograph |
|---|---|---|---|---|---|
| CA.<br>B.0004 | Building B<br>Rooftop<br>Southern<br>Parapet<br>Wall<br>Overflow | Water filled blisters behind the facade coating above and surrounding the southern central overflow outlet indicating a failure of the wall coating. | <p>The Builder has failed to prevent water penetrating beneath the wall coating.</p> <p>HBA Part 2C clause 18B(a) breach: 'a warranty that the work will be done with due care and skill and in accordance with the plans and specifications set out in the contract,'</p> <p>HBA Part 2C clause 18B(b) breach: 'a warranty that all materials supplied by the holder or person will be good and suitable for the purpose for which they are used and that, unless otherwise stated in the contract, those materials will be new; and</p> <p>HBA Part 2C clause 18B(c) breach: 'a warranty that the work will be done in accordance with, and will comply with, this or any other law'.</p> <p>The defects also represent failures by the Builder to comply with one of, or a combination of the following:</p> <p>BCA SECTION F HEALTH AND AMENITY – PART F1 DAMP AND WEATHERPROOFING: FUNCTIONAL STATEMENTS FF1.2:<br/>A building is to be constructed to provide resistance to moisture penetration from the outside including rising from the ground.</p> <p>BCA - SECTION F HEALTH AND AMENITY - Part F1 DAMP AND WEATHERPROOFING: PERFORMANCE REQUIREMENTS FP:1.4:<br/>'A roof and external wall (incl openings around windows and doors) must prevent the penetration of water that could cause.<br/>(a) unhealthy or dangerous conditions, or loss of amenity to occupants, and<br/>(b) undue dampness or deterioration of building element'.</p> | <p>The damaged facade coating should be locally removed and the substrate allowed to dry. The wall section should then be prepared for coating in accordance with the procedures stipulated in AS2311. An elastomeric coating should then be applied to the top and both internal and external; face of the wall to the nearest control joint and or architectural break to ensure continuity of the face sealed system. Works should generally comply with the requirements of AS2311 and AS4654. All works should be done in accordance with the product manufacturers recommendations.</p> | <p>20250501_112742.jpg 1/05/25 11:27 AM -33.907778,151.153412</p> |

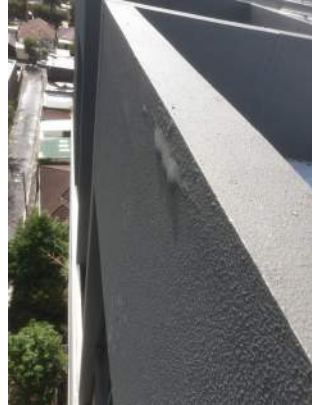
| Item | Area | Defect | Substantiation | Actions | Defect Photograph |
|---|---|---|---|---|---|
| CA.<br>B.0005 | Building B<br>Rooftop<br>South End<br>of West<br>Facing<br>Parapet<br>External | Water filled blisters behind the facade coating to the western elevation indicating a failure of the wall coating. | <p>The Builder has failed to prevent water penetrating beneath the wall coating.</p> <p>HBA Part 2C clause 18B(a) breach: 'a warranty that the work will be done with due care and skill and in accordance with the plans and specifications set out in the contract,'</p> <p>HBA Part 2C clause 18B(b) breach: 'a warranty that all materials supplied by the holder or person will be good and suitable for the purpose for which they are used and that, unless otherwise stated in the contract, those materials will be new; and</p> <p>HBA Part 2C clause 18B(c) breach: 'a warranty that the work will be done in accordance with, and will comply with, this or any other law'.</p> <p>The defects also represent failures by the Builder to comply with one of, or a combination of the following:</p> <p>BCA SECTION F HEALTH AND AMENITY – PART F1 DAMP AND WEATHERPROOFING: FUNCTIONAL STATEMENTS FF1.2:<br/>A building is to be constructed to provide resistance to moisture penetration from the outside including rising from the ground.</p> <p>BCA - SECTION F HEALTH AND AMENITY - Part F1 DAMP AND WEATHERPROOFING: PERFORMANCE REQUIREMENTS FP:1.4:<br/>'A roof and external wall (incl openings around windows and doors) must prevent the penetration of water that could cause.<br/>(a) unhealthy or dangerous conditions, or loss of amenity to occupants, and<br/>(b) undue dampness or deterioration of building element'.</p> | <p>The damaged facade coating should be locally removed and the substrate allowed to dry. The wall section should then be prepared for coating in accordance with the procedures stipulated in AS2311. An elastomeric coating should then be applied to the top and both internal and external; face of the wall to the nearest control joint and or architectural break to ensure continuity of the face sealed system. Works should generally comply with the requirements of AS2311 and AS4654. All works should be done in accordance with the product manufacturers recommendations.</p> | <p>20250501_112920.jpg 1/05/25 11:29 AM -33.907716,151.153354</p> |

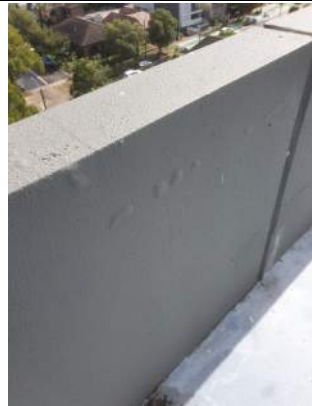
| Item | Area | Defect | Substantiation | Actions | Defect Photograph |
|---|---|---|---|---|---|
| CA.<br>B.0006 | Building B<br>Rooftop<br>South End<br>of West<br>Facing<br>Parapet<br>Internal | Water filled blisters behind the facade coating to the internal side of the western elevation indicating a failure of the wall coating. | <p>The Builder has failed to prevent water penetrating beneath the wall coating.</p> <p>HBA Part 2C clause 18B(a) breach: 'a warranty that the work will be done with due care and skill and in accordance with the plans and specifications set out in the contract,'</p> <p>HBA Part 2C clause 18B(b) breach: 'a warranty that all materials supplied by the holder or person will be good and suitable for the purpose for which they are used and that, unless otherwise stated in the contract, those materials will be new; and</p> <p>HBA Part 2C clause 18B(c) breach: 'a warranty that the work will be done in accordance with, and will comply with, this or any other law'.</p> <p>The defects also represent failures by the Builder to comply with one of, or a combination of the following:</p> <p>BCA SECTION F HEALTH AND AMENITY – PART F1 DAMP AND WEATHERPROOFING: FUNCTIONAL STATEMENTS FF1.2:<br/>A building is to be constructed to provide resistance to moisture penetration from the outside including rising from the ground.</p> <p>BCA - SECTION F HEALTH AND AMENITY - Part F1 DAMP AND WEATHERPROOFING: PERFORMANCE REQUIREMENTS FP:1.4:<br/>'A roof and external wall (incl openings around windows and doors) must prevent the penetration of water that could cause.<br/>(a) unhealthy or dangerous conditions, or loss of amenity to occupants, and<br/>(b) undue dampness or deterioration of building element'.</p> | <p>The damaged facade coating should be locally removed and the substrate allowed to dry. The wall section should then be prepared for coating in accordance with the procedures stipulated in AS2311. An elastomeric coating should then be applied to the top and both internal and external; face of the wall to the nearest control joint and or architectural break to ensure continuity of the face sealed system. Works should generally comply with the requirements of AS2311 and AS4654. All works should be done in accordance with the product manufacturers recommendations.</p> | <p>20250501_113121.jpg 1/05/25 11:31 AM -33.907640,151.153329</p> |

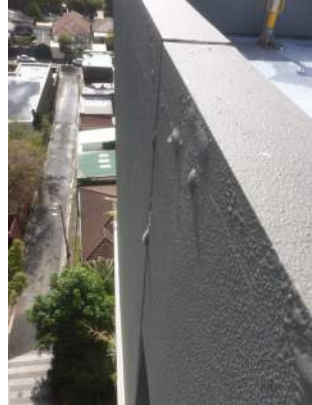
| Item | Area | Defect | Substantiation | Actions | Defect Photograph |
|---|---|---|---|---|---|
| CA.<br>B.0007 | Building B<br>Rooftop<br>North End<br>of West<br>Facing<br>Parapet<br>External | Water filled blisters behind the facade coating to the western elevation indicating a failure of the wall coating. | <p>The Builder has failed to prevent water penetrating beneath the wall coating.</p> <p>HBA Part 2C clause 18B(a) breach: 'a warranty that the work will be done with due care and skill and in accordance with the plans and specifications set out in the contract,'</p> <p>HBA Part 2C clause 18B(b) breach: 'a warranty that all materials supplied by the holder or person will be good and suitable for the purpose for which they are used and that, unless otherwise stated in the contract, those materials will be new; and</p> <p>HBA Part 2C clause 18B(c) breach: 'a warranty that the work will be done in accordance with, and will comply with, this or any other law'.</p> <p>The defects also represent failures by the Builder to comply with one of, or a combination of the following:</p> <p>BCA SECTION F HEALTH AND AMENITY – PART F1 DAMP AND WEATHERPROOFING: FUNCTIONAL STATEMENTS FF1.2:<br/>A building is to be constructed to provide resistance to moisture penetration from the outside including rising from the ground.</p> <p>BCA - SECTION F HEALTH AND AMENITY - Part F1 DAMP AND WEATHERPROOFING: PERFORMANCE REQUIREMENTS FP:1.4:<br/>'A roof and external wall (incl openings around windows and doors) must prevent the penetration of water that could cause.<br/>(a) unhealthy or dangerous conditions, or loss of amenity to occupants, and<br/>(b) undue dampness or deterioration of building element'.</p> | <p>The damaged facade coating should be locally removed and the substrate allowed to dry. The wall section should then be prepared for coating in accordance with the procedures stipulated in AS2311. An elastomeric coating should then be applied to the top and both internal and external; face of the wall to the nearest control joint and or architectural break to ensure continuity of the face sealed system. Works should generally comply with the requirements of AS2311 and AS4654. All works should be done in accordance with the product manufacturers recommendations.</p> | <p>20250501_113125.jpg 1/05/25 11:31 AM -33.907629,151.153312</p> |

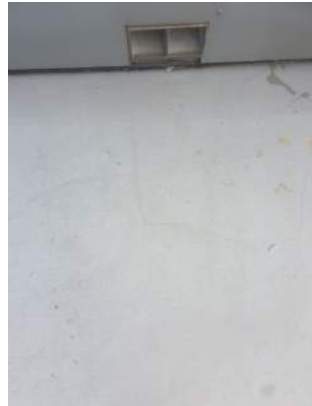
| Item | Area | Defect | Substantiation | Actions | Defect Photograph |
|---|---|---|---|---|---|
| CA.<br>B.0008 | Building B<br>Northern<br>End of<br>Rooftop<br>Central Bay | Topping applied to the substrate has cracked and caused separation of the applied waterproof membrane. | <p>The Builder has failed to provide a continuous barrier impervious to water as per the requirements of AS4654.2.</p> <p>HBA Part 2C clause 18B(a) breach: 'a warranty that the work will be done with due care and skill and in accordance with the plans and specifications set out in the contract,'</p> <p>HBA Part 2C clause 18B(b) breach: 'a warranty that all materials supplied by the holder or person will be good and suitable for the purpose for which they are used and that, unless otherwise stated in the contract, those materials will be new; and</p> <p>HBA Part 2C clause 18B(c) breach: 'a warranty that the work will be done in accordance with, and will comply with, this or any other law'.</p> <p>The defects also represent failures by the Builder to comply with one of, or a combination of the following:</p> <p>BCA SECTION F HEALTH AND AMENITY – PART F1 DAMP AND WEATHERPROOFING: FUNCTIONAL STATEMENTS FF1.2:<br/>A building is to be constructed to provide resistance to moisture penetration from the outside including rising from the ground.</p> <p>BCA - SECTION F HEALTH AND AMENITY - Part F1 DAMP AND WEATHERPROOFING: PERFORMANCE REQUIREMENTS FP:1.4:<br/>'A roof and external wall (incl openings around windows and doors) must prevent the penetration of water that could cause.<br/>(a) unhealthy or dangerous conditions, or loss of amenity to occupants, and<br/>(b) undue dampness or deterioration of building element'.</p> <p>AS 4654.2 External Waterproofing Membranes for above ground use, Part 2 Design and Installation, Section 1.3 Definitions, Clause 1.3.6 Membrane; 'An impervious barrier to liquid or water... '.</p> | <p>Locally remove the membrane coating along the cracks. Grind out the cracks to a depth of 5mm and a width of 5mm. Fill the newly created chase with a semi flexible epoxy mortar. Prepare the surface and reapply waterproofing membrane in strict accordance with both AS4654.2 and the membrane manufacturers recommendations.</p> | <p>20250501_113308.jpg 1/05/25 11:33 AM -33.907610,151.153429</p> |

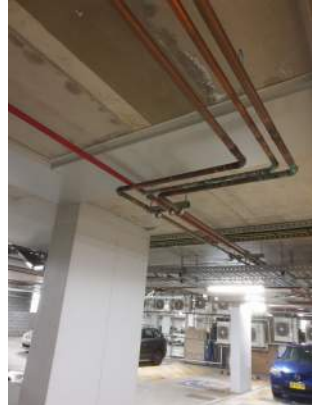
| Item | Area | Defect | Substantiation | Actions | Defect Photograph |
|---|---|---|---|---|---|
| CP.000<br>1 | Carpark<br>Visitor<br>Level<br>Infill Slab<br>Above<br>Disabled<br>Parking | Water ingress identified associated with the cold joint of the infill slab above the disabled parking bays. Installed catch trays and negative membrane inadequate with active leaks. Top side waterproofing has failed. | <p>The Builder has failed to effectively waterproof the podium above allowing for uncontrolled water ingress into the carpark and long term exposure of the steel reinforcement elements within slab infill to water which will lead to spalling and premature failure of the steel elements.</p> <p>The author considers the recorded defects to be non-compliant with the following statutory requirements:<br/>HBA Part 2C clause 18B(a) breach: 'a warranty that the work will be done with due care and skill and in accordance with the plans and specifications set out in the contract; and<br/>HBA Part 2C clause 18B(c) breach: 'a warranty that the work will be done in accordance with, and will comply with, this or any other law'.</p> <p>The defects also represent failures by the Builder to comply with one of, or a combination of the following:<br/>BCA SECTION B STRUCTURE – PART B1 STRUCTURAL PROVISIONS: FUNCTIONAL STATEMENTS BF1.1:<br/>'A building or structure is to withstand the combination of loads and other actions to which it may be reasonably subjected.'<br/>BCA SECTION F HEALTH AND AMENITY – PART F1 DAMP AND WEATHERPROOFING: FUNCTIONAL STATEMENTS FF1.2:<br/>'A building is to be constructed to provide resistance to moisture penetration from the outside including rising from the ground.'<br/>BCA - SECTION F HEALTH AND AMENITY - Part F1 DAMP AND WEATHERPROOFING: PERFORMANCE REQUIREMENTS FP:1.4:<br/>'A roof and external wall (incl openings around windows and doors) must prevent the penetration of water that could cause.<br/>(a) unhealthy or dangerous conditions, or loss of amenity to occupants, and<br/>(b) undue dampness or deterioration of building element'.<br/>BCA - SECTION F HEALTH AND AMENITY - Part F1 DAMP AND WEATHERPROOFING: DEEMED-TO-SATISFY PROVISIONS F1.4 EXTERNAL ABOVE GROUND MEMBRANES:<br/>'Waterproofing membranes for external above ground use must comply with AS 4654 Parts 1 and 2'.</p> | Remove hard landscaping elements concealing the cold joints above. Waterproof joints in accordance with the requirements of AS4654.2. Reinstate hard landscaping elements and make good all affected finishes. | <p>20250501_143209.jpg 1/05/25 2:32 PM -33.908171,151.152918</p> |

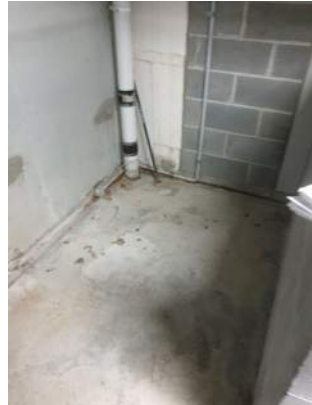
| Item | Area | Defect | Substantiation | Actions | Defect Photograph |
|---|---|---|---|---|---|
| CP.000<br>2 | Carpark<br>Visitor<br>Level<br>North East<br>Fire Exit | Water ingress beneath wall adjacent to fire exit door indicating a failure of the waterproof membrane externally. | <p>The Builder has failed to effectively waterproof the external landing allowing for uncontrolled water penetration into the carpark.</p> <p>The author considers the recorded defects to be non-compliant with the following statutory requirements:<br/>HBA Part 2C clause 18B(a) breach: 'a warranty that the work will be done with due care and skill and in accordance with the plans and specifications set out in the contract; and<br/>HBA Part 2C clause 18B(c) breach: 'a warranty that the work will be done in accordance with, and will comply with, this or any other law'.</p> <p>The defects also represent failures by the Builder to comply with one of, or a combination of the following:<br/>BCA SECTION F HEALTH AND AMENITY – PART F1 DAMP AND WEATHERPROOFING: FUNCTIONAL STATEMENTS FF1.2:<br/>'A building is to be constructed to provide resistance to moisture penetration from the outside including rising from the ground.'<br/>BCA - SECTION F HEALTH AND AMENITY - Part F1 DAMP AND WEATHERPROOFING: DEEMED-TO-SATISFY PROVISIONS F1.4 EXTERNAL ABOVE GROUND MEMBRANES:<br/>'Waterproofing membranes for external above ground use must comply with AS 4654 Parts 1 and 2'.</p> | The paved finishes to the area external to the wall are to be removed exposing the waterproof membrane. The waterproof membrane junction to the wall is to be rectified in accordance with the requirements of AS4654.2. Reinstate paving and make good affected finishes. | <p>20250501_143942.jpg 1/05/25 2:39 PM</p> |

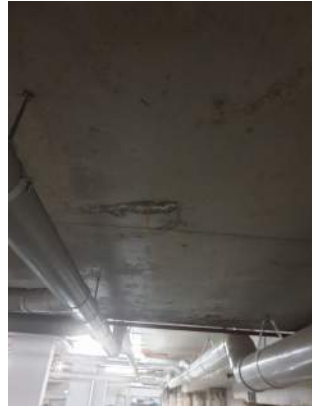
| Item | Area | Defect | Substantiation | Actions | Defect Photograph |
|---|---|---|---|---|---|
| CP.000<br>4 | Carpark<br>Visitor<br>Level<br>Lot 88<br>Parking<br>Bay | Crack in slab above Lot 88 (western boundary) Parking Bay leaching efflorescence. | <p>The Builder has failed to effectively waterproof the external landing allowing for uncontrolled water penetration into the carpark.</p> <p>The author considers the recorded defects to be non-compliant with the following statutory requirements:<br/> HBA Part 2C clause 18B(a) breach: 'a warranty that the work will be done with due care and skill and in accordance with the plans and specifications set out in the contract; and<br/> HBA Part 2C clause 18B(c) breach: 'a warranty that the work will be done in accordance with, and will comply with, this or any other law'.</p> <p>The defects also represent failures by the Builder to comply with one of, or a combination of the following:<br/> BCA SECTION B STRUCTURE – PART B1 STRUCTURAL PROVISIONS: FUNCTIONAL STATEMENTS BF1.1:<br/> 'A building or structure is to withstand the combination of loads and other actions to which it may be reasonably subjected.'<br/> BCA SECTION F HEALTH AND AMENITY – PART F1 DAMP AND WEATHERPROOFING: FUNCTIONAL STATEMENTS FF1.2:<br/> 'A building is to be constructed to provide resistance to moisture penetration from the outside including rising from the ground'.<br/> BCA - SECTION F HEALTH AND AMENITY - Part F1 DAMP AND WEATHERPROOFING: PERFORMANCE REQUIREMENTS FP:1.4:<br/> 'A roof and external wall (incl openings around windows and doors) must prevent the penetration of water that could cause.<br/> (a) unhealthy or dangerous conditions, or loss of amenity to occupants, and<br/> (b) undue dampness or deterioration of building element'.<br/> BCA - SECTION F HEALTH AND AMENITY - Part F1 DAMP AND WEATHERPROOFING: DEEMED-TO-SATISFY PROVISIONS F1.4 EXTERNAL ABOVE GROUND MEMBRANES:<br/> 'Waterproofing membranes for external above ground use must comply with AS 4654 Parts 1 and 2'.<br/> AS 3600 – SECTION 2 DESIGN PROCEDURES, ACTIONS AND LOADS; 2.3 DESIGN FOR SERVICEABILITY; 2.3.3 CRACKING; 2.3.3.1 GENERAL:<br/> 'Cracking in concrete structures shall be controlled so that structural performance, durability and appearance of the structure is not compromised'.</p> | Remove hard landscaping elements concealing the waterproofing above. Remove existing waterproofing to parent substrate, prepare and re waterproof the external landing in accordance with the requirements of AS4654.2. Perform crack injection to the crack using a proprietary system in strict accordance with the manufacturers recommendations. Reinstate hard landscaping elements and make good all affected finishes. | <p>20250501_144556.jpg 1/05/25 2:45 PM</p> |

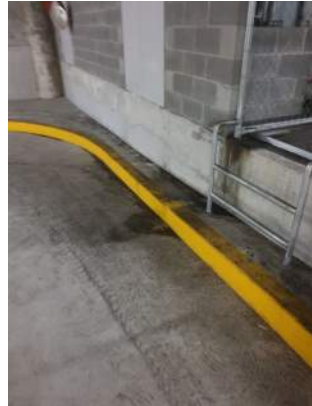
| Item | Area | Defect | Substantiation | Actions | Defect Photograph |
|---|---|---|---|---|---|
| CP.000<br>6 | Carpark<br>Visitor<br>Level<br>Fire Tank Room | Water leak from Fire Tank Room distributing uncontrolled water to the Visitor/B1 carpark ramp. | <p>Further investigations are required to verify the presence of the alleged defect. Further investigations were conducted on the 8/10/25. Access was gained to the fire tank room. No leaks were identified associated with the fire tank itself. A number of aluminium water stops and waterproofing bandages have been installed to the perimeter of the room presumably to manage storm water ingress. Based on both this inspection and our previous inspection storm water running down the west facing wall is bypassing these waterproofing measures and making its way to the driveway. It is understood that the below grade wall will allow water ingress but it must be controlled.</p> <p>The author considers the recorded defects to be non-compliant with the following statutory requirements:<br/> HBA Part 2C clause 18B(a) breach: 'a warranty that the work will be done with due care and skill and in accordance with the plans and specifications set out in the contract; and<br/> HBA Part 2C clause 18B(c) breach: 'a warranty that the work will be done in accordance with, and will comply with, this or any other law'.</p> <p>The defects also represent failures by the Builder to comply with one of, or a combination of the following:<br/> BCA SECTION B STRUCTURE – PART B1 STRUCTURAL PROVISIONS: FUNCTIONAL STATEMENTS BF1.1:<br/> 'A building or structure is to withstand the combination of loads and other actions to which it may be reasonably subjected'.<br/> BCA SECTION F HEALTH AND AMENITY – PART F1 DAMP AND WEATHERPROOFING: FUNCTIONAL STATEMENTS FF1.2:<br/> 'A building is to be constructed to provide resistance to moisture penetration from the outside including rising from the ground'.<br/> BCA - SECTION F HEALTH AND AMENITY - Part F1 DAMP AND WEATHERPROOFING: PERFORMANCE REQUIREMENTS FP:1.4:<br/> 'A roof and external wall (incl openings around windows and doors) must prevent the penetration of water that could cause.<br/> (a) unhealthy or dangerous conditions, or loss of amenity to occupants, and<br/> (b) undue dampness or deterioration of building element'.</p> | Either repair the existing water containment measures or introduce a new drain along the boundary wall plumbed into the existing car park drainage systems. | <p>20250501_145135.jpg 1/05/25 2:51 PM</p> |

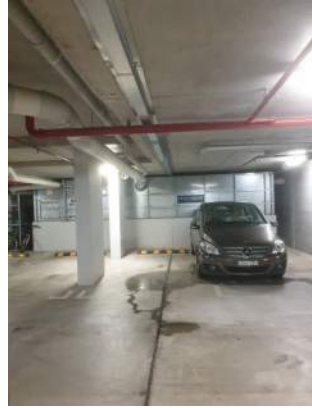
| Item | Area | Defect | Substantiation | Actions | Defect Photograph |
|---|---|---|---|---|---|
| CP.0009 | Carpark B1 Construction Joint Above Lot 171/212 Parking Bays | Active water ingress identified through the construction joint situated between 178 Livingstone and 18 Lilydale affecting trafficable areas and Lot 171 storage cage. Installed catch trays not effective. Top side waterproofing has failed. | <p>The Builder has failed to effectively detail and waterproof the construction joint above allowing for uncontrolled water ingress into the carpark and long term exposure of the steel reinforcement elements within construction joint to water which will lead to spalling and premature failure of the steel elements.</p> <p>The author considers the recorded defects to be non-compliant with the following statutory requirements:<br/> HBA Part 2C clause 18B(a) breach: 'a warranty that the work will be done with due care and skill and in accordance with the plans and specifications set out in the contract; and<br/> HBA Part 2C clause 18B(c) breach: 'a warranty that the work will be done in accordance with, and will comply with, this or any other law'.</p> <p>The defects also represent failures by the Builder to comply with one of, or a combination of the following:<br/> BCA SECTION B STRUCTURE – PART B1 STRUCTURAL PROVISIONS: FUNCTIONAL STATEMENTS BF1.1:<br/> 'A building or structure is to withstand the combination of loads and other actions to which it may be reasonably subjected.'<br/> BCA SECTION F HEALTH AND AMENITY – PART F1 DAMP AND WEATHERPROOFING: FUNCTIONAL STATEMENTS FF1.2:<br/> A building is to be constructed to provide resistance to moisture penetration from the outside including rising from the ground.<br/> BCA - SECTION F HEALTH AND AMENITY - Part F1 DAMP AND WEATHERPROOFING: PERFORMANCE REQUIREMENTS FP:1.4:<br/> 'A roof and external wall (incl openings around windows and doors) must prevent the penetration of water that could cause.<br/> (a) unhealthy or dangerous conditions, or loss of amenity to occupants, and<br/> (b) undue dampness or deterioration of building element'.<br/> BCA - SECTION F HEALTH AND AMENITY - Part F1 DAMP AND WEATHERPROOFING: DEEMED-TO-SATISFY PROVISIONS F1.4 EXTERNAL ABOVE GROUND MEMBRANES:<br/> 'Waterproofing membranes for external above ground use must comply with AS 4654 Parts 1 and 2'.<br/> AS 3600 - SECTION 14 JOINTS, EMBEDDED ITEMS AND FIXINGS, 14.1 JOINTS, 14.1.4 JOINT FILLERS AND SEALANTS.</p> | Remove hard landscaping elements concealing the construction joint above. Detail and waterproof joint in accordance with the requirements of AS3600 and AS4654.2. Reinstall hard landscaping elements and make good all affected finishes. | <p>20250501_150456.jpg 1/05/25 3:04 PM</p> |

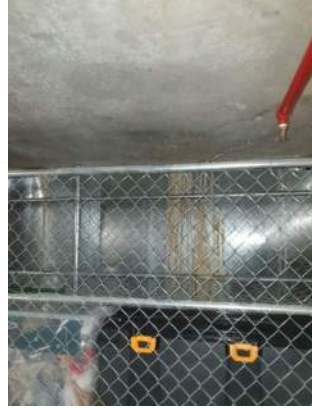
| Item | Area | Defect | Substantiation | Actions | Defect Photograph |
|---|---|---|---|---|---|
| CP.001<br>1 | Carpark<br>B2<br>Soffit<br>above Lot<br>169<br>Parking<br>Bay<br>Storage<br>Cage | Crack in slab above<br>Lot 169 Parking<br>Bay leaching<br>efflorescence and<br>allowing water<br>ingress into storage<br>cages. | <p>The Builder has failed to effectively control cracking in the concrete slab and prevent uncontrolled water ingress into the storage cages.</p> <p>The author considers the recorded defects to be non-compliant with the following statutory requirements:</p> <p>HBA Part 2C clause 18B(a) breach: <i>'a warranty that the work will be done with due care and skill and in accordance with the plans and specifications set out in the contract; and</i></p> <p>HBA Part 2C clause 18B(c) breach: <i>'a warranty that the work will be done in accordance with, and will comply with, this or any other law'.</i></p> <p>The defects also represent failures by the Builder to comply with one of, or a combination of the following:</p> <p>BCA SECTION B STRUCTURE – PART B1 STRUCTURAL PROVISIONS: FUNCTIONAL STATEMENTS BF1.1:<br/><i>'A building or structure is to withstand the combination of loads and other actions to which it may be reasonably subjected.'</i></p> <p>BCA SECTION F HEALTH AND AMENITY – PART F1 DAMP AND WEATHERPROOFING: FUNCTIONAL STATEMENTS FF1.2:<br/><i>A building is to be constructed to provide resistance to moisture penetration from the outside including rising from the ground.</i></p> <p>BCA - SECTION F HEALTH AND AMENITY - Part F1 DAMP AND WEATHERPROOFING: PERFORMANCE REQUIREMENTS FP:1.4:<br/><i>'A roof and external wall (incl openings around windows and doors) must prevent the penetration of water that could cause.</i><br/><i>(a) unhealthy or dangerous conditions, or loss of amenity to occupants, and</i><br/><i>(b) undue dampness or deterioration of building element'.</i></p> <p>AS 3600 – SECTION 2 DESIGN PROCEDURES, ACTIONS AND LOADS; 2.3 DESIGN FOR SERVICEABILITY; 2.3.3 CRACKING; 2.3.3.1 GENERAL:<br/><i>'Cracking in concrete structures shall be controlled so that structural performance, durability and appearance of the structure is not compromised'.</i></p> | <p>Identify water source by investigation of drainage provisions and retaining walls above. Rectify drainage provisions to comply with AS3500.3. Perform crack injection to the crack using a proprietary system in strict accordance with the manufacturers recommendations.</p> | <p>20250501_152806.jpg 1/05/25 3:28 PM</p> |
