Report: robert brandon-combined building & pest inspection

## Pre Purchase Building Inspection Report

**12 Winifred Street  
Morwell, vic 3840**

**May 8, 2026**

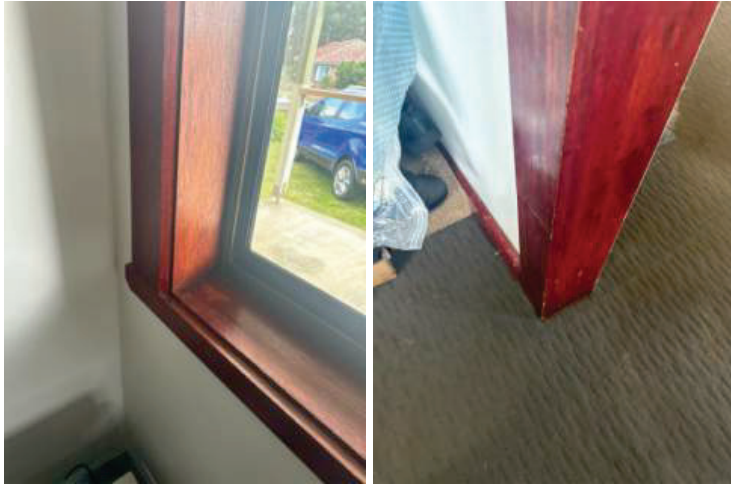
The condition of the woodwork is generally fair.

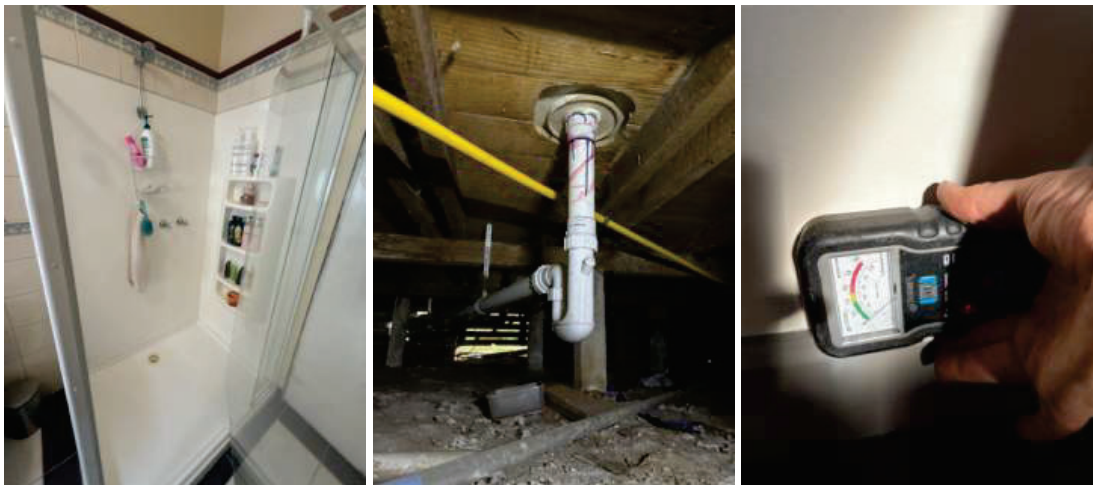
The shower recess was tested and there was no visible water penetration to surrounding areas. **IMPORTANT NOTE:** This test may not reveal water leaks until the shower is put into constant use and surrounding areas monitored over a period of time. Ongoing Maintenance is strongly advised.

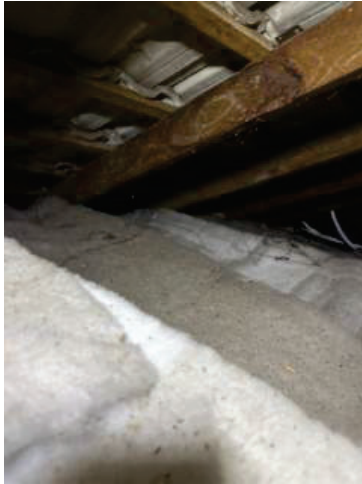
Inspection over the eaves and low areas to the perimeter of the building was restricted due to the low pitch and method of construction allowing only a limited visual inspection from a distance. Items such as top plates and ceiling and roof framing in these areas was not able to be fully inspected. Defects and or timber pest may be present and not detected.

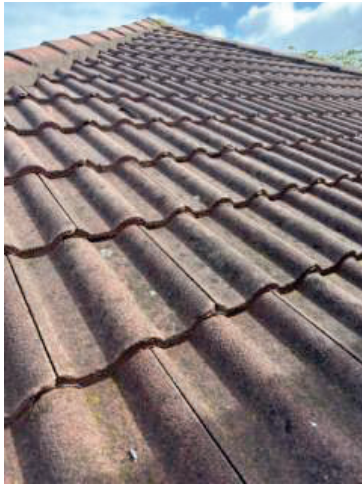
Due to it raining at the time of the inspection, the roofing materials were of a type that could not be safely walked on. There for the external roof inspection was very limited, and only viewed from a distance. A more detailed assessment of the roof material beyond this report is suggested, a licensed roofing experts opinion should be commissioned prior to making a decision on this property as defects may be present and not detected.

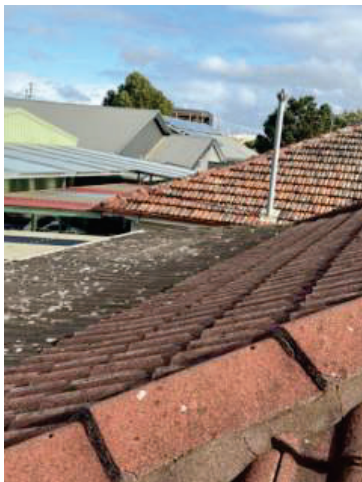
The overall condition of the roof coverings visible from a ladder appears serviceable. It should be noted that sometimes defects are very small and not clearly visible from an inspection viewed from a ladder and its possible defects may be present and not detected. Its recommended that a licensed roofing expert be hired to provide an additional closer assessment of the roof coverings.

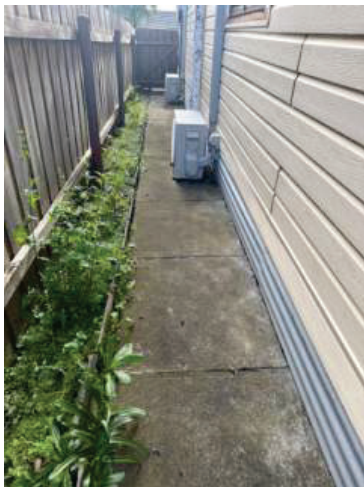
The concrete paths/paved areas are in fair condition.

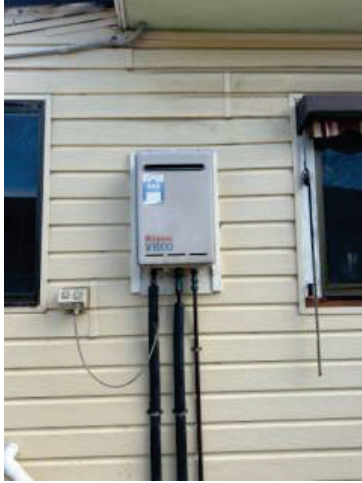
Instantaneous: Located externally: The hot water system appears to be in working condition. No specific tests other than running the hot water from a tap was carried out. No determination has been made as to the suitability or adequacy of the hot water system in relation to capacity or otherwise.
