Building & Pest Inspection Report

PRO VISION PROPERTY INSPECTIONS

14 Panorama Close, Fletcher, New South Wales, 2287

Inspection Date: 22 Oct 2024

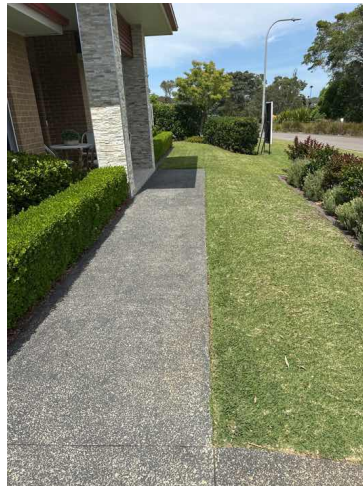
Pathways Condition

The paths around the home are in a serviceable condition for the age of this dwelling. Common minor cracking may still exist.

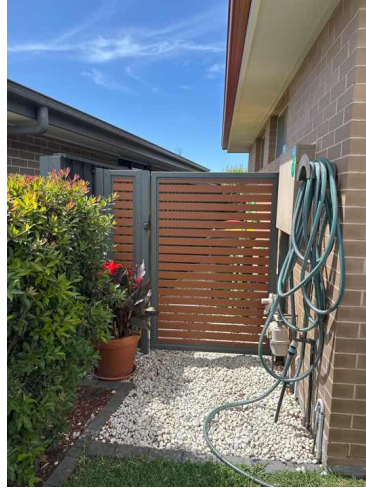
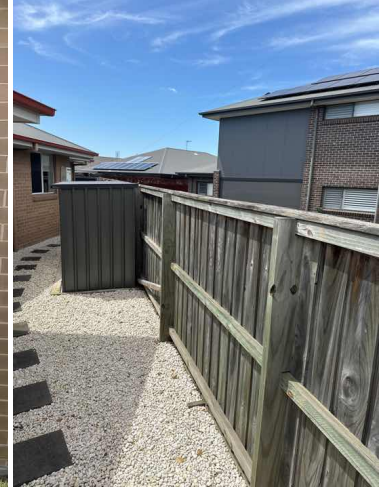
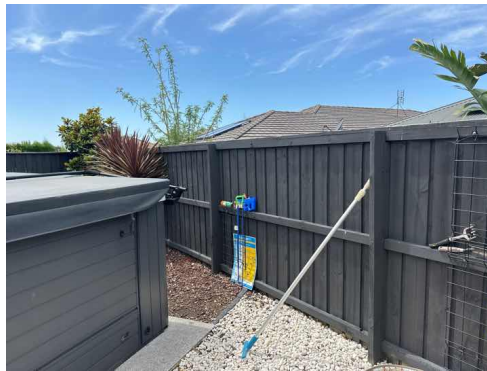
Overall Condition

Of the visible areas, the general condition of the fences and gates is serviceable for the age of dwelling.

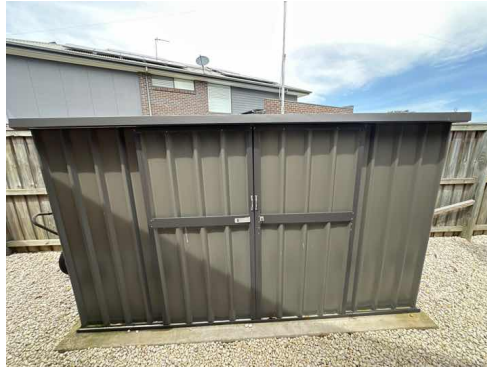
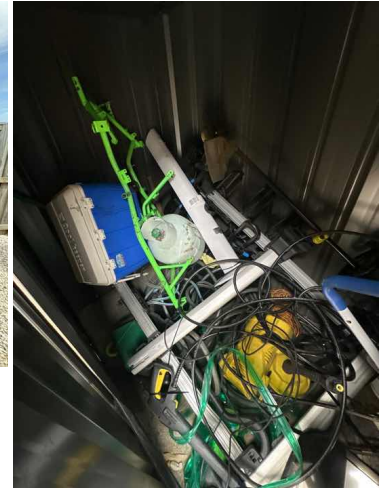
Shed Condition

The shed is in fair usable condition.

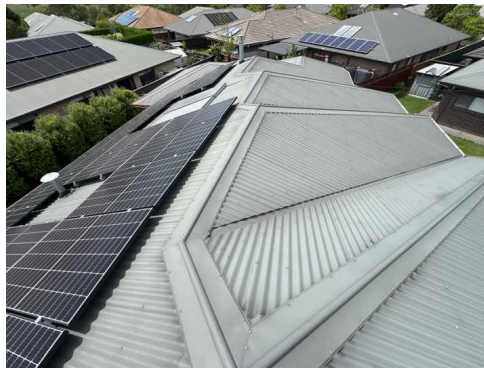
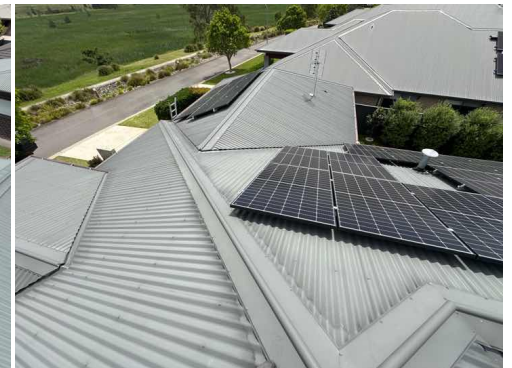
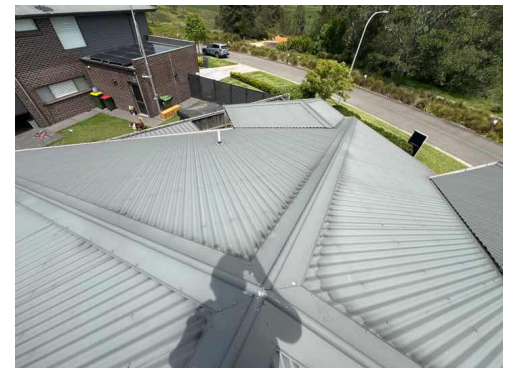
Overall Condition

Of the visible areas, the general condition of the roof is in serviceable condition for the age. Note: In the absence of rainfall there is no guarantee that the roof won't leak.

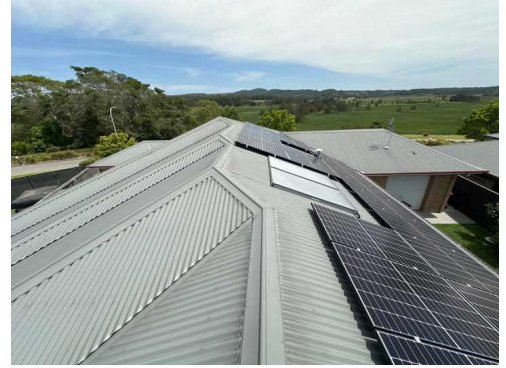
Roof Clad Condition

Visible section of The roof cladding appeared in a serviceable condition for the age of this dwelling. Annual maintenance inspection recommended.

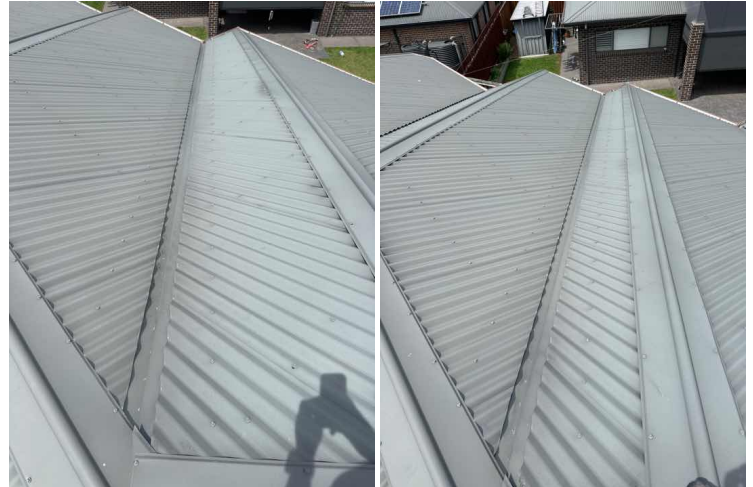
Flashing Conditions

The flashing appears to be serviceable.

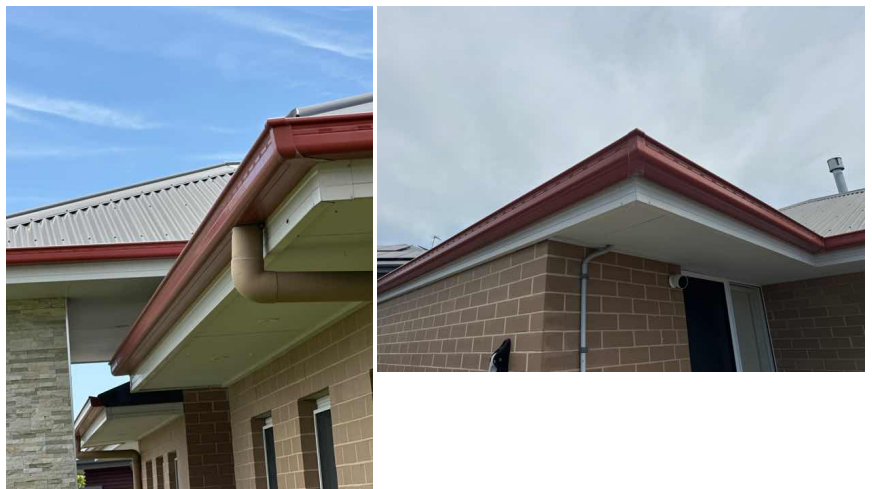
Gutter Findings

All visible and accessible of the physical nature of the guttering system appears to be in a serviceable condition with no apparent defects at the time of inspection. In the absence of prolonged rain fall efficiency of the guttering can not be assessed and you may find that further investigation or repairs maybe required. Note: Periodic maintenance checks should be carried out for rust penetrations and leaks.

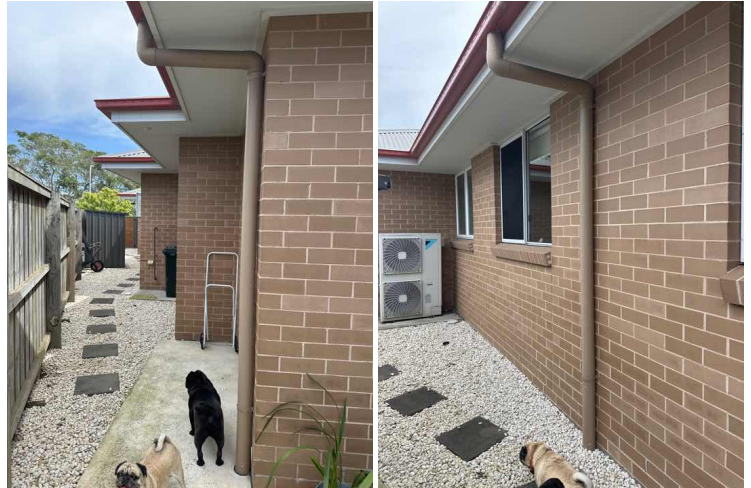
Downpipe Findings

On visual inspection no apparent defects were noted to the down pipes and are considered serviceable, however no comment can be made with regard to blockages or connections to stormwater or functionality in the absence of rain. Note: Periodic maintenance checks should be carried out for rust penetrations and leaks.

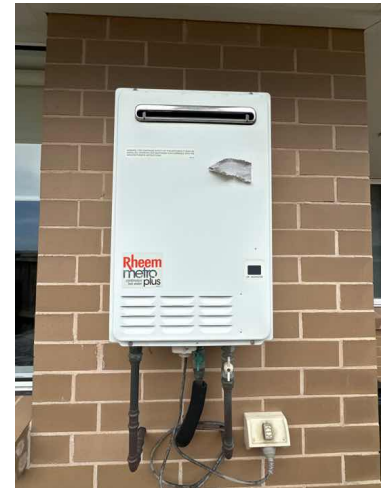
Hot Water Unit Findings

The hot water system appears to be in a serviceable condition. No specific tests other than running the hot water from a tap was carried out. No determination has been made as to the suitability or adequacy of the hot water system in relation to capacity or otherwise.

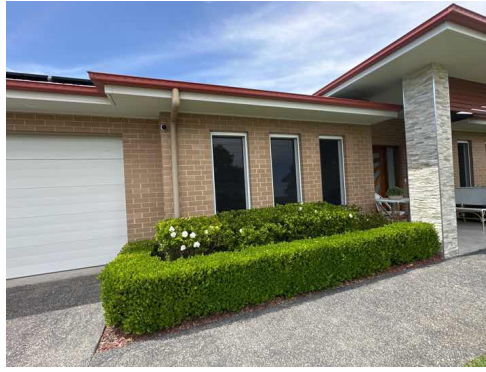
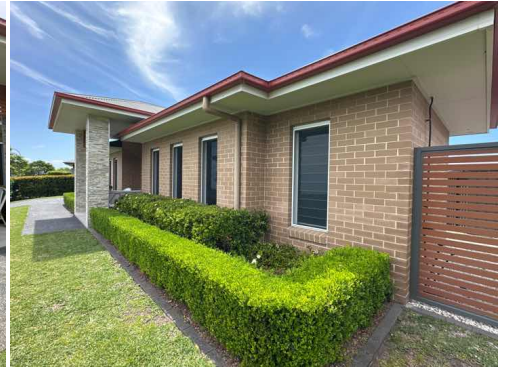
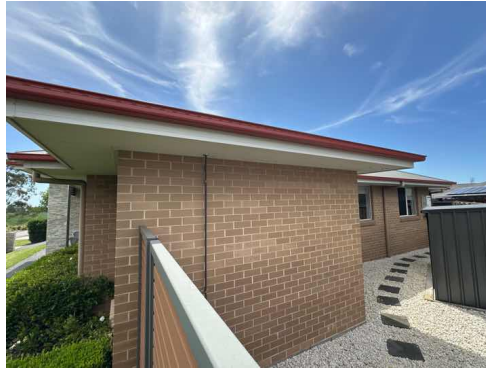
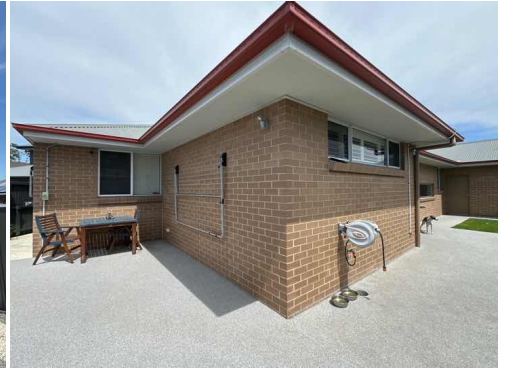
Condition

On visual inspection, the general condition of the exterior walls is serviceable for the age.

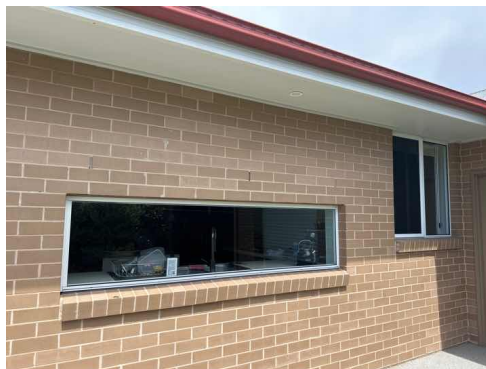
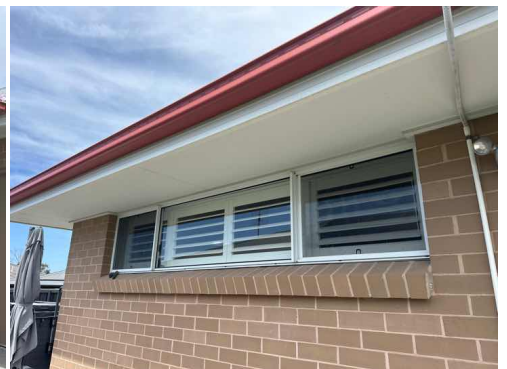
Overall Condition

On visual inspection, the general condition of the windows is serviceable for the age of the dwelling. Minor aging, deterioration may still exist depending on the age

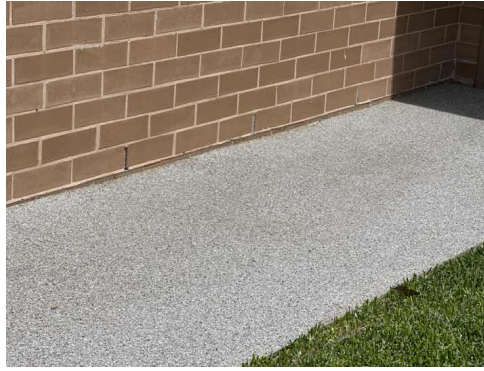
Findings

The weep holes are unobstructed .

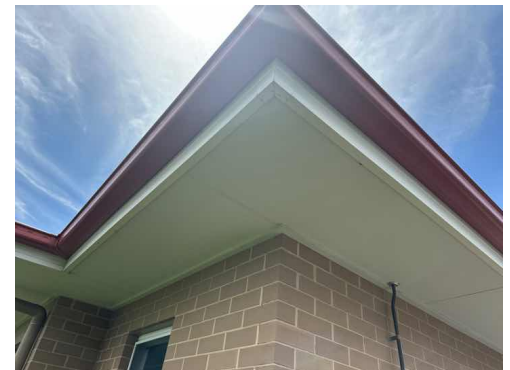
Eave Condition

The soffit lining (eaves) are in a serviceable condition with no notable defects.

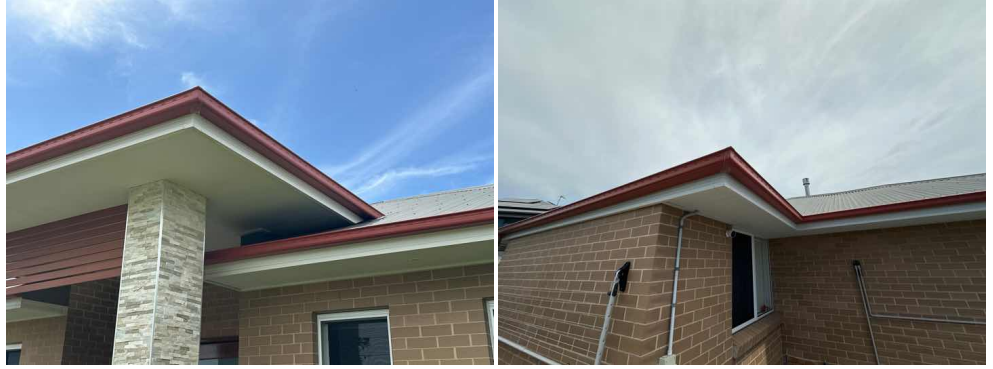
Condition

On visual inspection, the general condition of the fascia/barge boards is serviceable.

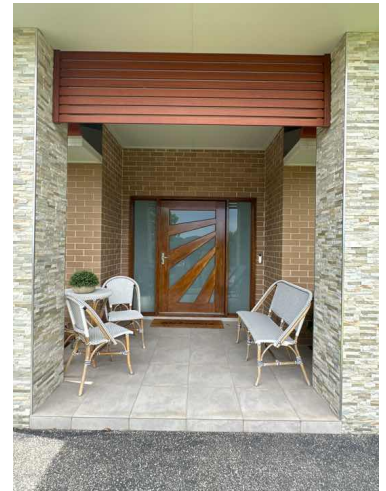
Overall Condition

The entry porch serviceable or in reasonable or condition for the age of this dwelling.

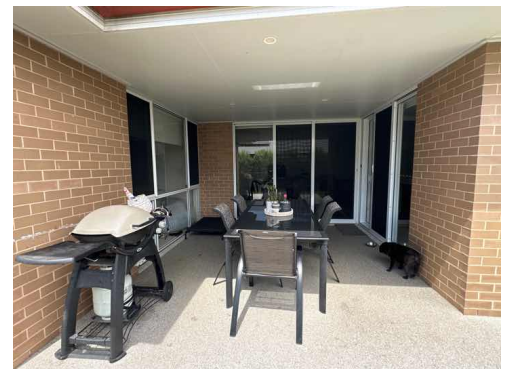
Overall Condition

The entry porch serviceable or in reasonable or condition for the age of this dwelling.

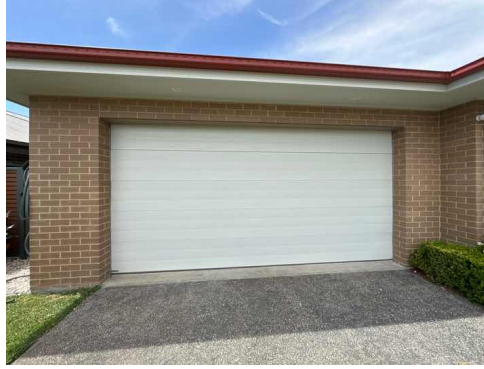
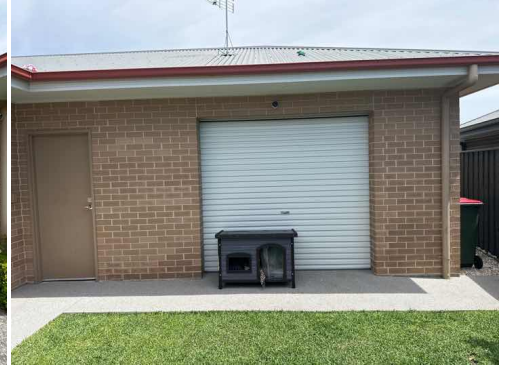
Stored items and or vehicles restricted a full and thorough inspection of this area. Defects may exist in the obstructed and inaccessible areas. It is strongly recommended that full access be granted to enable a thorough inspection of this area. Note: Where vehicles and storage has restricted a full inspection it is advised that this area be cleared so a full and unobstructed inspection can be carried out.

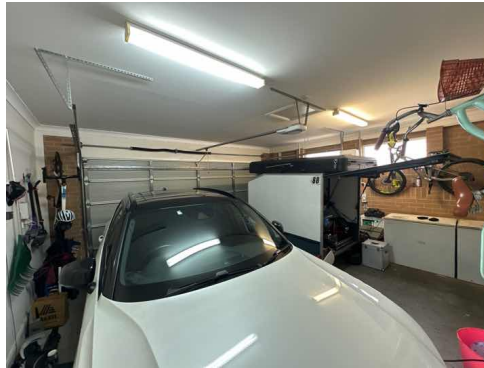
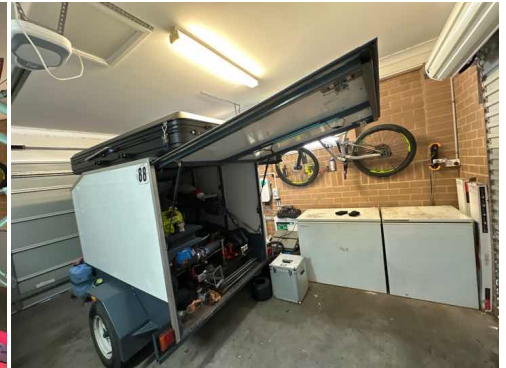
From the visible and accessible areas, the garage appears to be in a serviceable condition for the age of the property with no notable structural defects sighted.

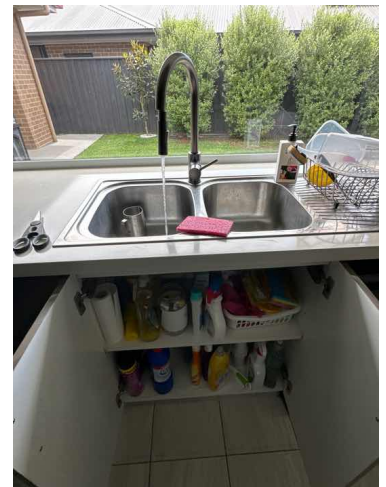
Sinks and taps were tested for minimum of 30 seconds. Pipework was checked for leaks, water pressure and water pipe hammer and waste pipes were inspected for blockages. No leaks or blockages were found. Please note that pipework/leaks can only be inspected when cupboards are free from stored items.

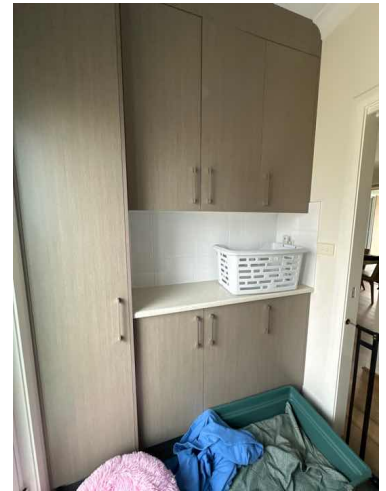
Cupboards And Bench Tops

These components appear to be in a serviceable condition

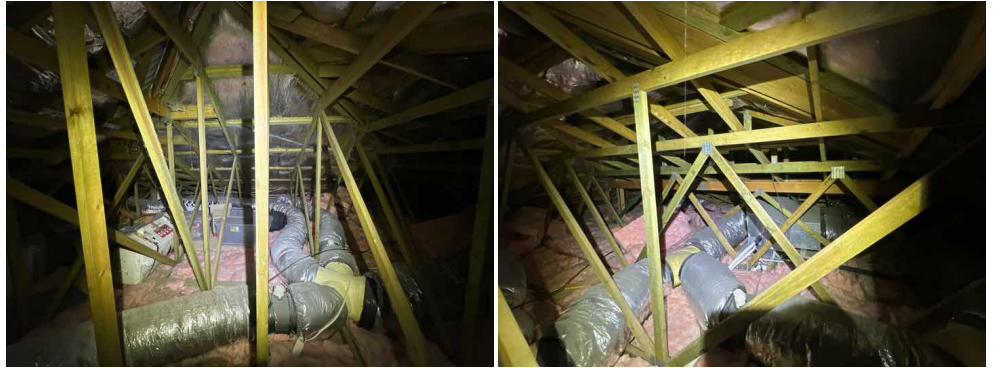
Roof Frame Type

The roof frame is a truss timber frame.

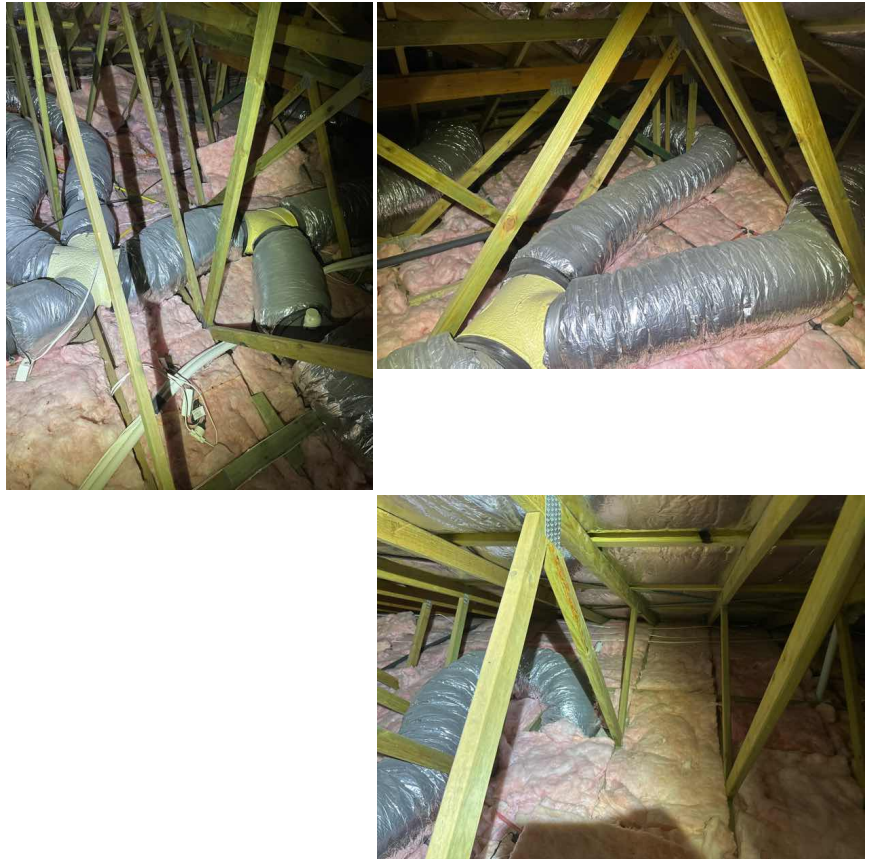
Type

The roof space is insulated with fibreglass batts.

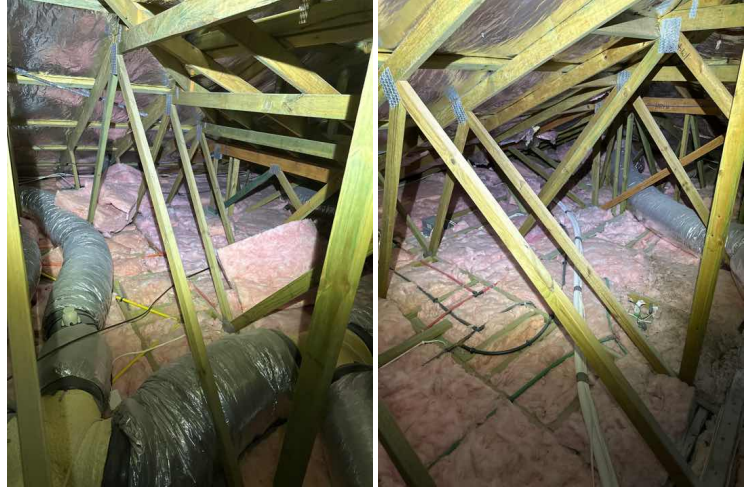
Condition

Where visible and accessible, the insulation appears to be in a serviceable condition.

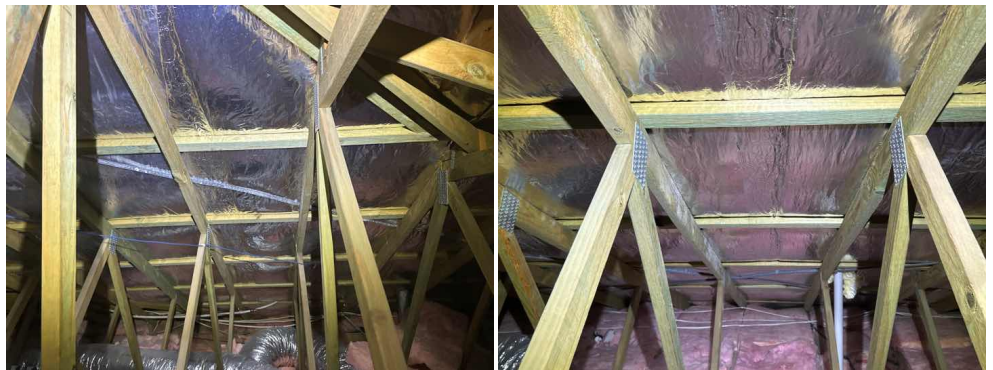
Sarking is installed and in serviceable condition.

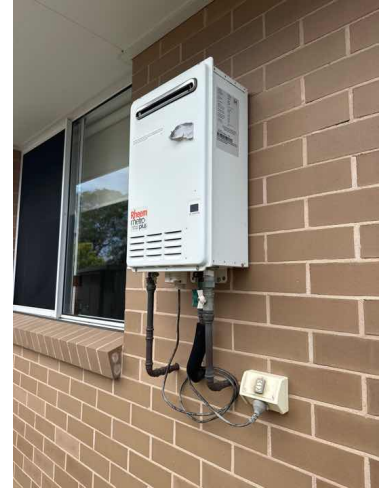
Was the overflow sufficiently drained

Not applicable to this type of hot water system.
